# Proactive Inspections Program Activity Report

APRIL - JUNE 2021

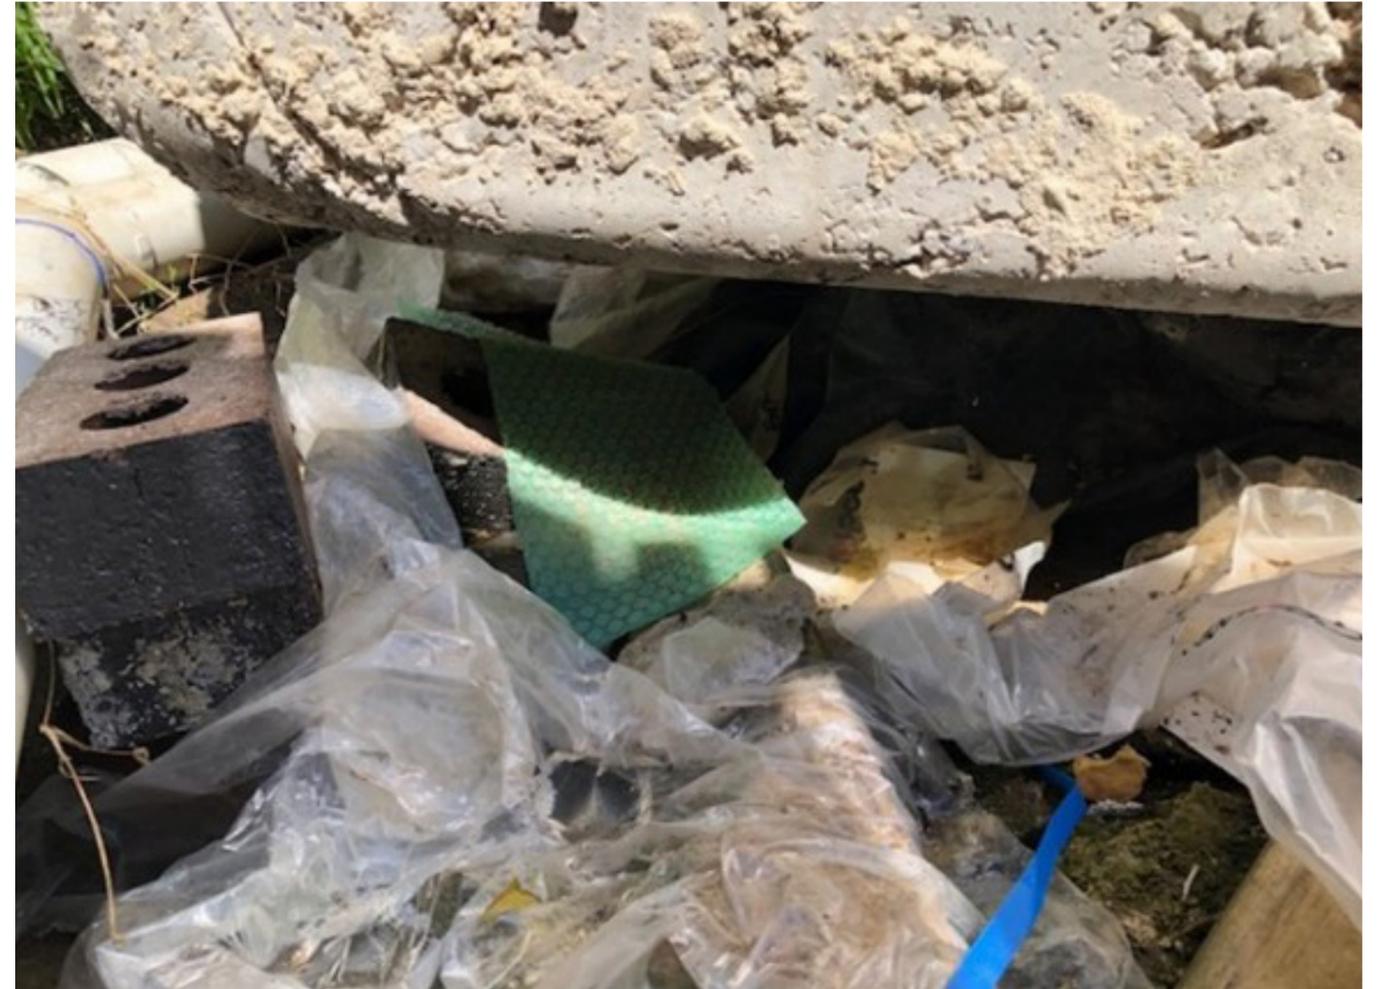
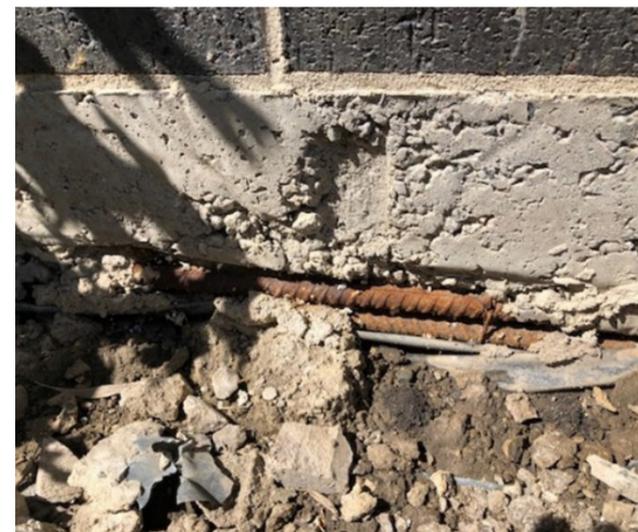
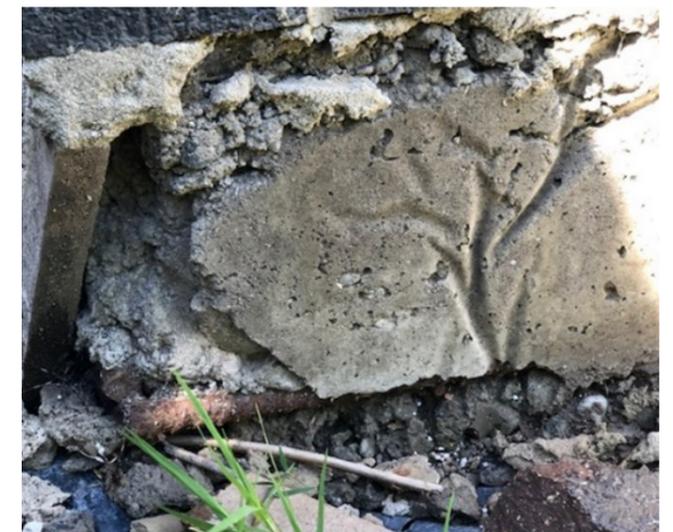
Serious foundations issues – concrete pier not installed as per engineering design

- observed a corner of the concrete slab edge beam (at the rear townhouse) was unsupported, and
- the foundation material had been washed away.

Also observed on site was exposed concrete slab steel reinforcement in multiple locations and therefore not covered by the minimum 40mm of concrete as required by clause 5.3.2 of AS 2870 – 2011.

The builder provided an approved rectification detail from the design engineer and photographic evidence of rectification work undertaken.

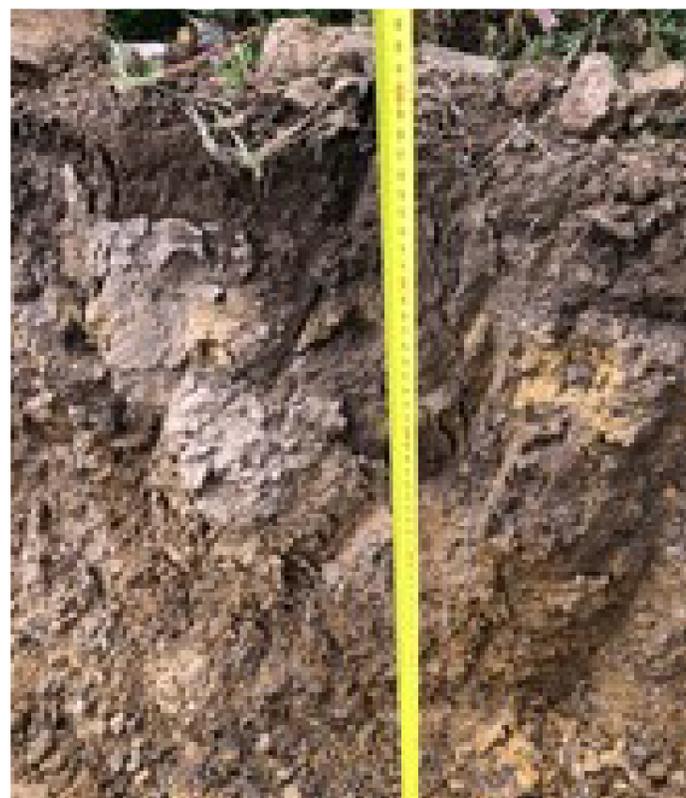
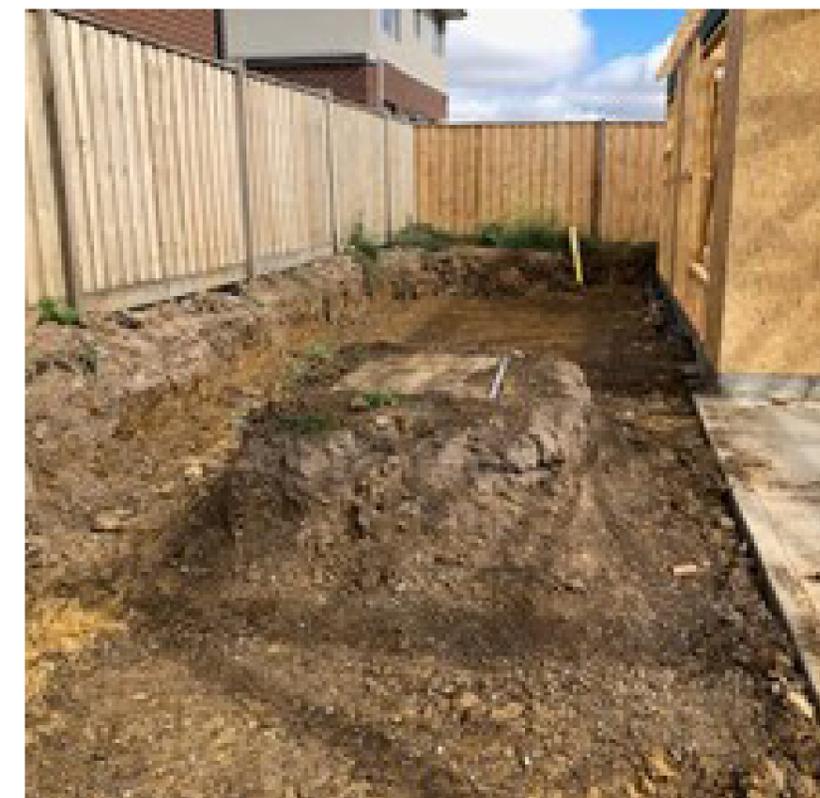
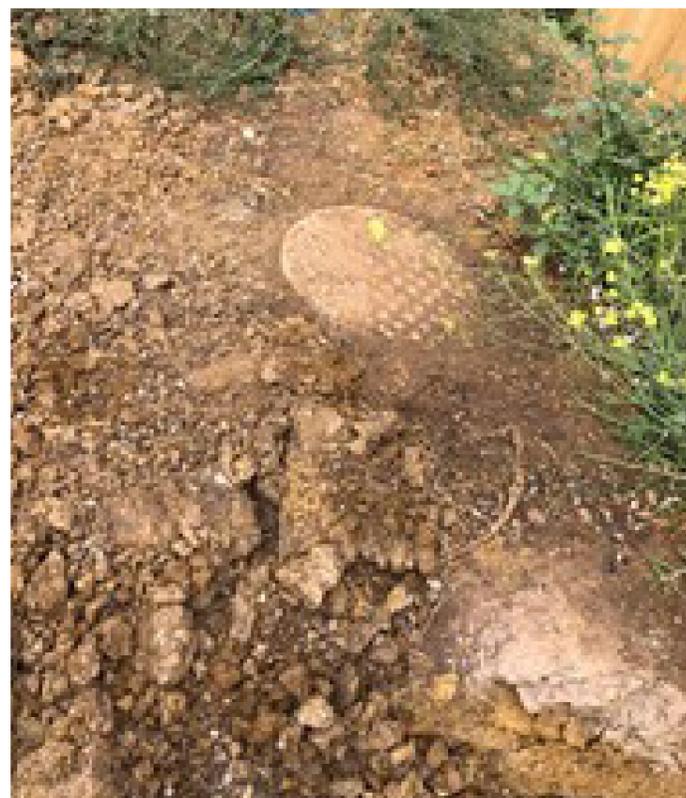
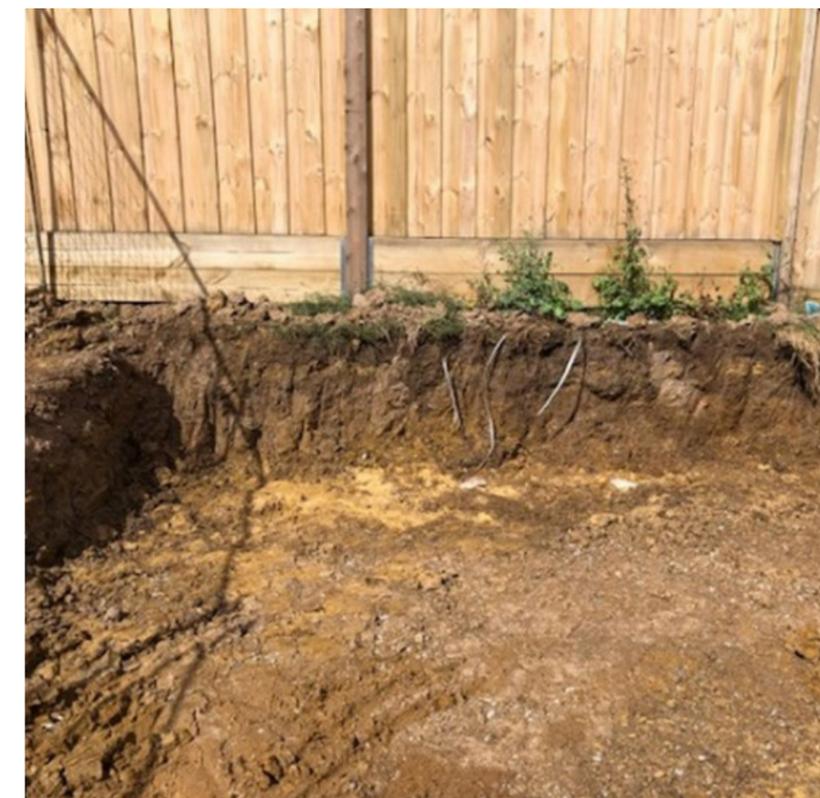
### Concession under C1.5 of Volume 1 incorrectly applied

As a result, the builder was referred to investigations for carrying out building work without having a building permit. The RBS was also referred for issuing a building permit without ensuring the Report and Consent of the relevant building authority was obtained.

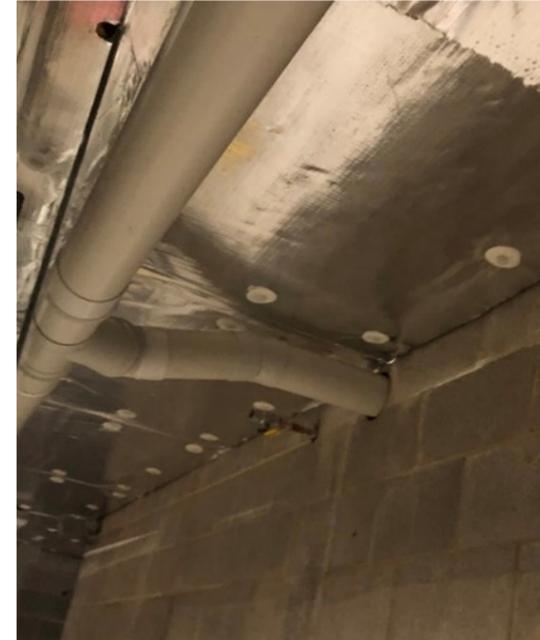
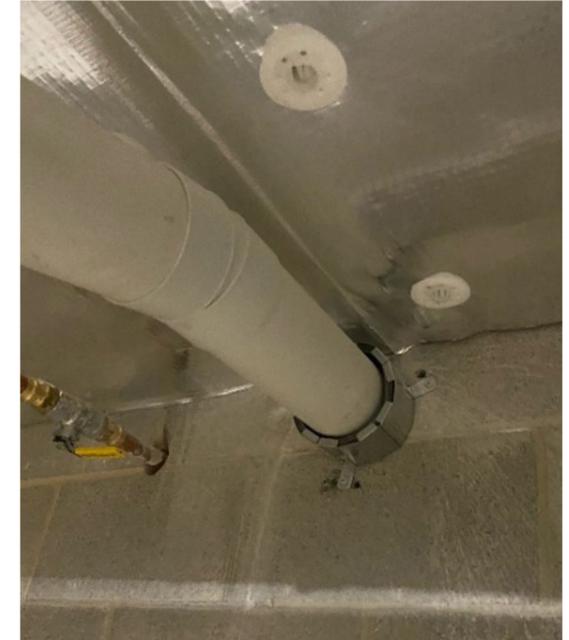
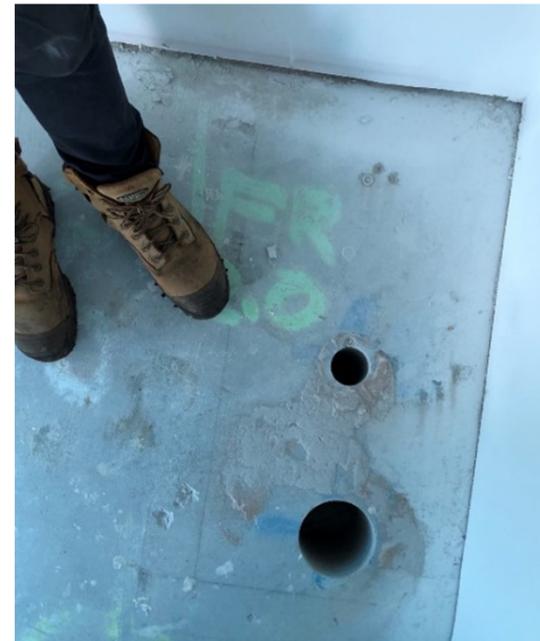
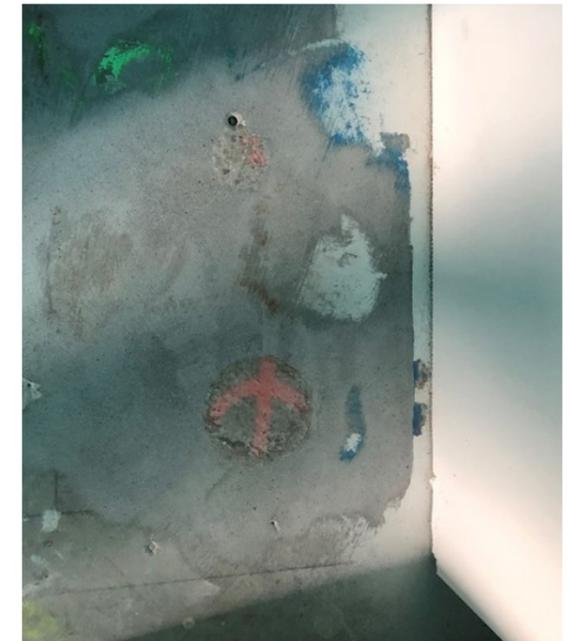
#### Protection of opening rectifications

### Inadequate protection of openings and non-compliant fire safety provisions

The VBA closed the matter after receiving comprehensive photographic evidence of the rectified work.

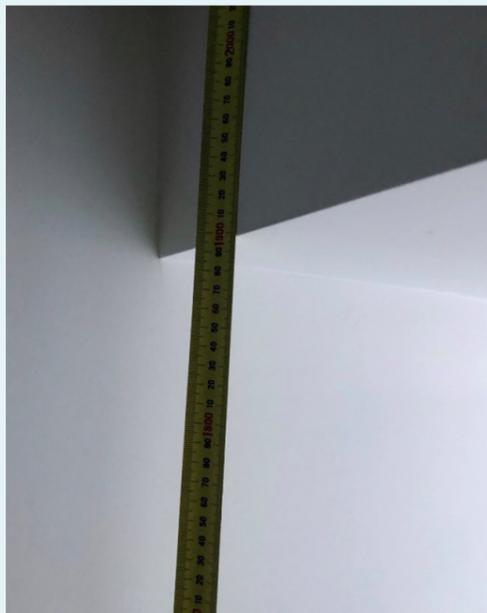
Ceiling height above the stairway was less than the minimum 2m

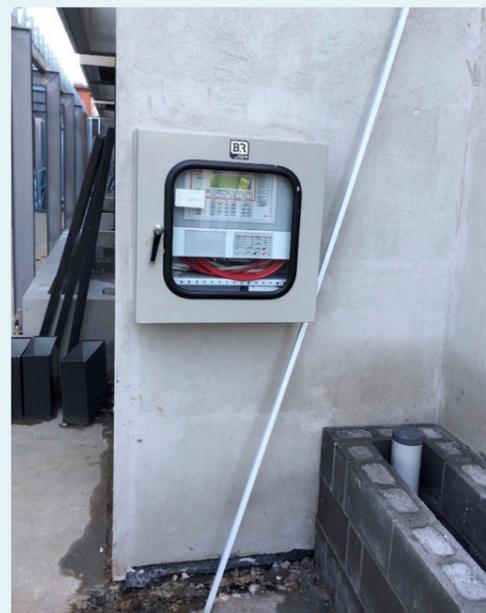
Minimum workspace clearances of the Fire Indicator Panel not met

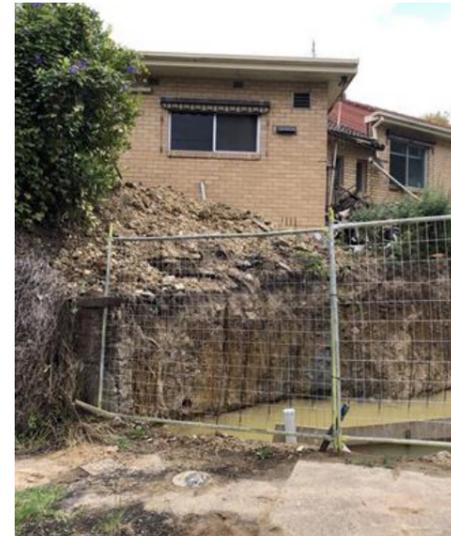
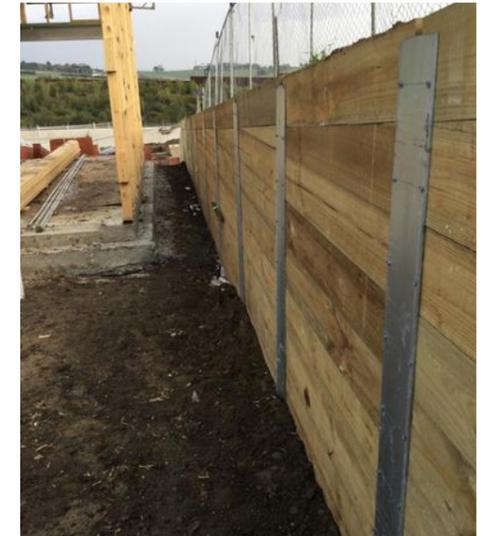
- backfill spoil (from an excavation for a below ground drainage) that had been stockpiled to a height exceeding 1.5m in without any protection or isolation of the spoil. This created a fall from heights risk, and
- excavation work for pier drilling that was unprotected and to a depth of 3.3m.

These matters were immediately reported to WorkSafe who attended the site and issued an improvement notice to the building practitioners to rectify.

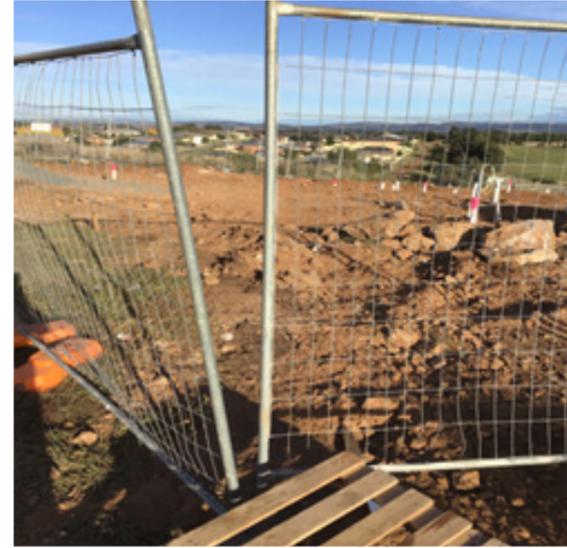
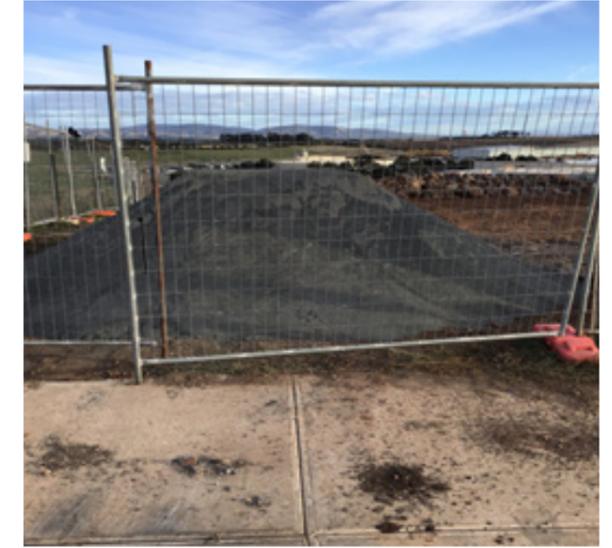
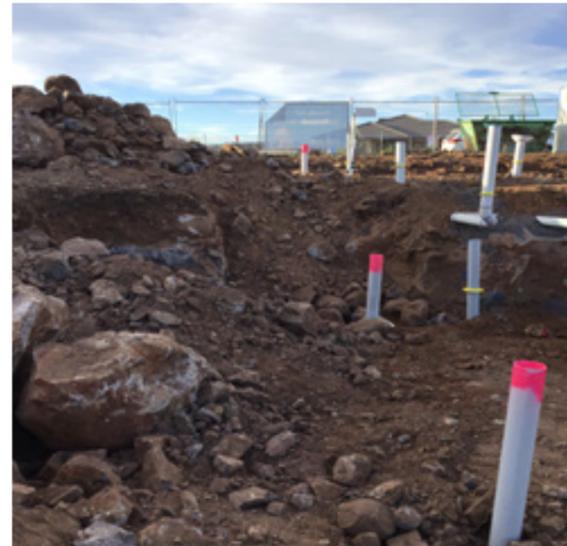
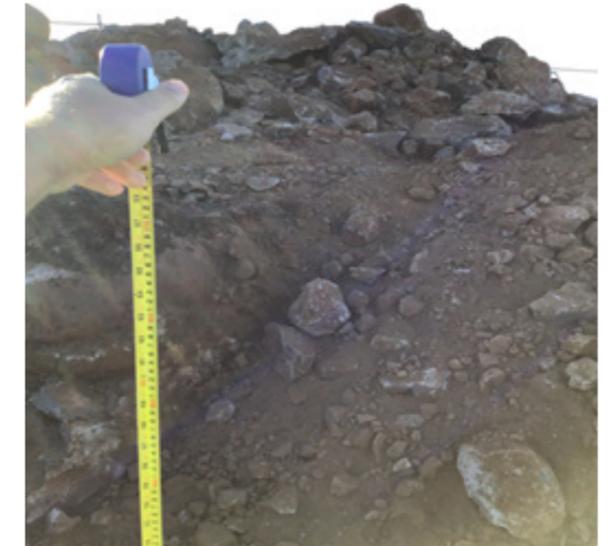
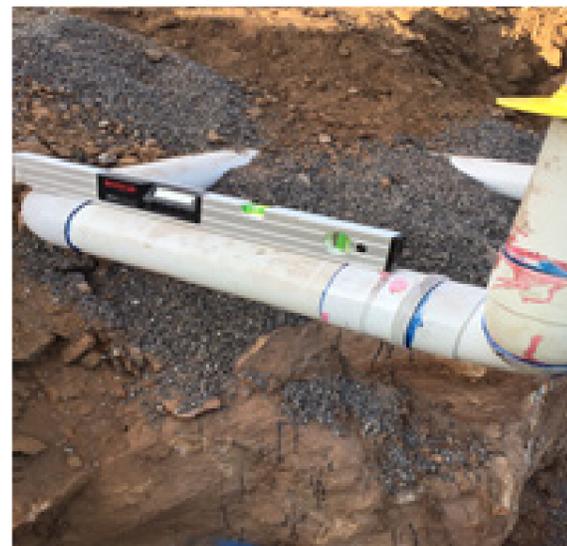
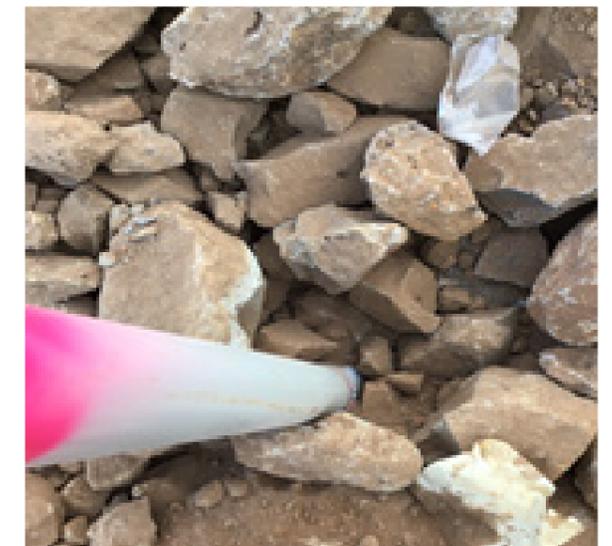
#### Inadequate protection from excavation work

- i. A below ground sewer drain installed
  - with insufficient grade (not in accordance with AS/NZS 3500.2:2018 Table 3.4.1 6),
  - without enough depth of cover according to AS/NZS 3500.2:2018 clause 3.7.2,
  - with inappropriate backfill material. AS/NZS 3500.2:2018 clause 5.4.4 & figure 5.4.4
  - with inappropriate bedding/side support material. AS/NZS 3500.2:2018 clause 5.4.2 & figure 5.4.4
- ii. Storm water drain with inappropriate fill material AS/NZS 3500.3:2018 clause 6.2.10

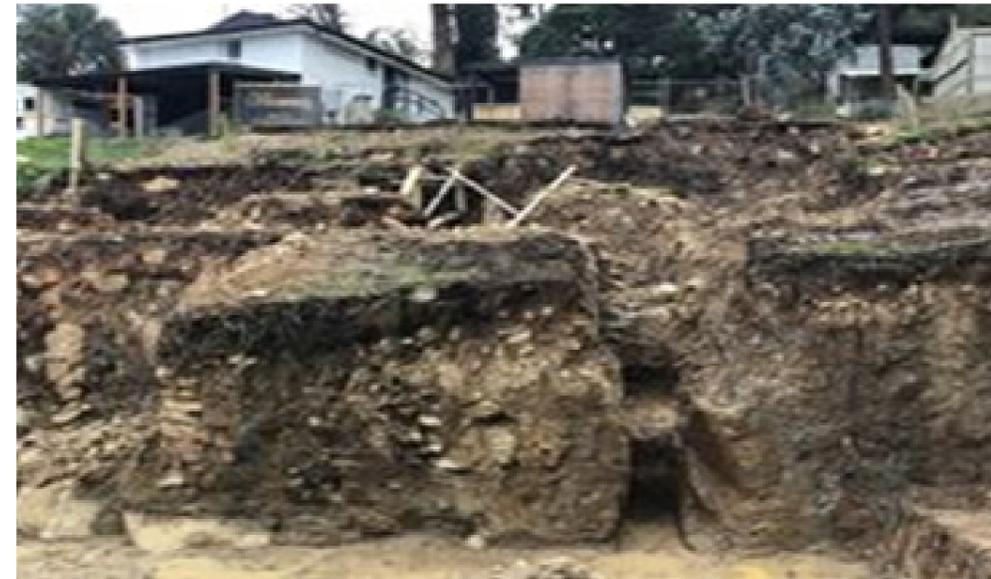
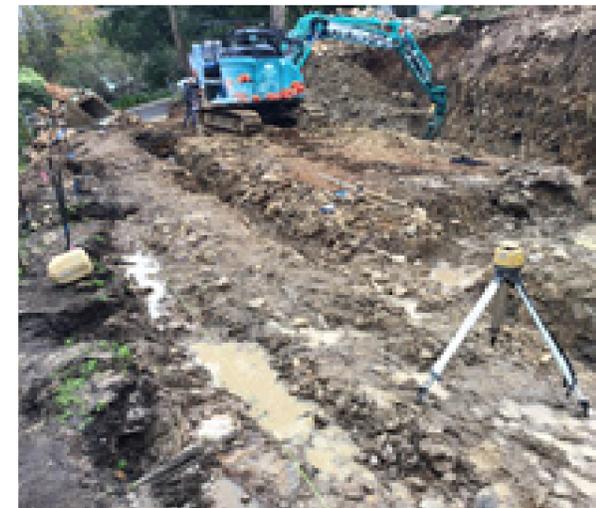
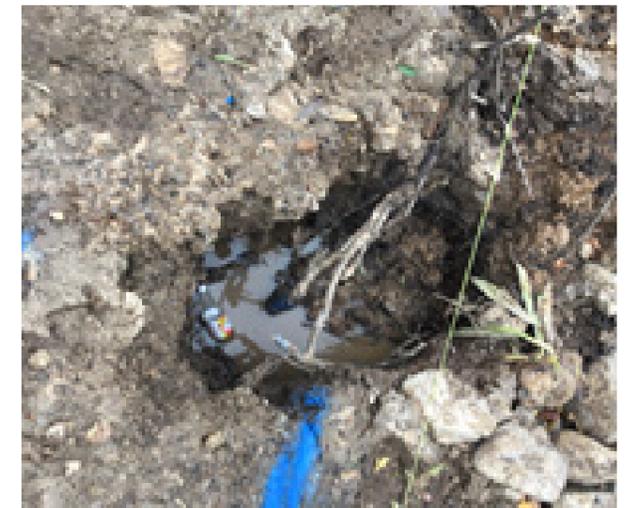
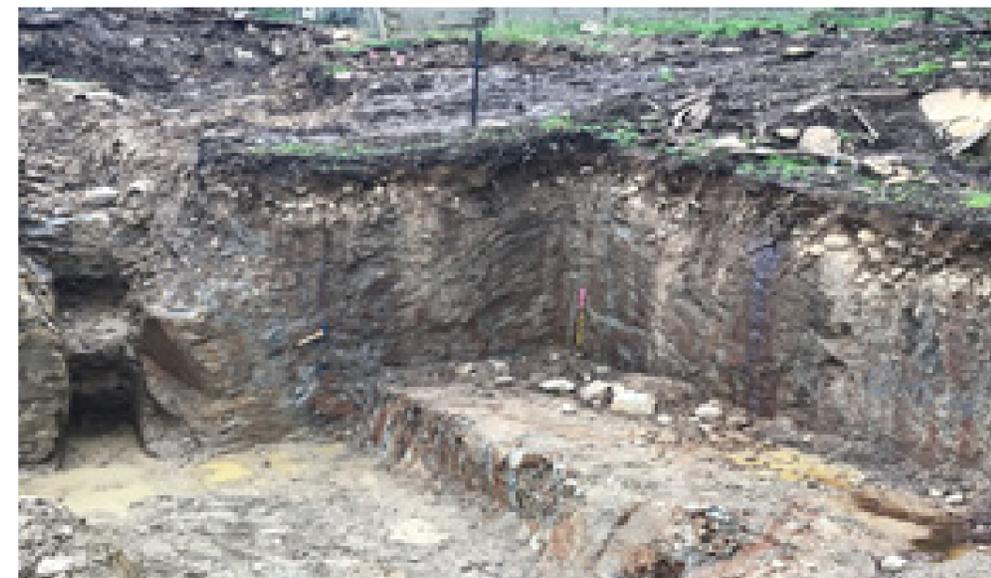
### Dangerous site cut

The proactive inspection of a single-storey dwelling under construction identified the excavation works being conducted for dwelling foundations were not safe because the pier drillings were unprotected and to a depth of 3.3 metres.

The building practitioner has now complied with the WorkSafe and MBS directions to ensure the site was made safe.

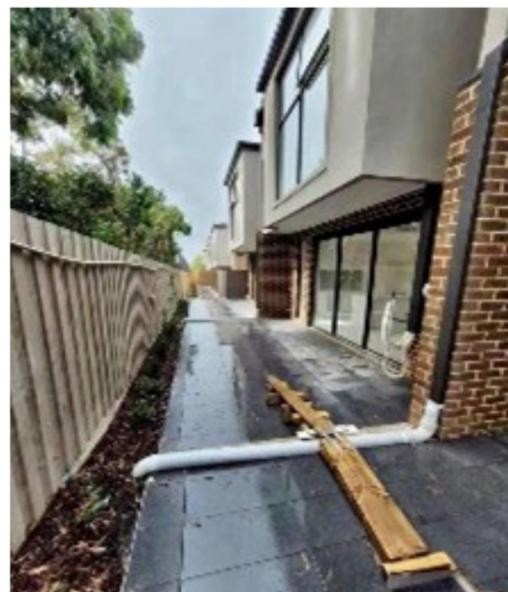
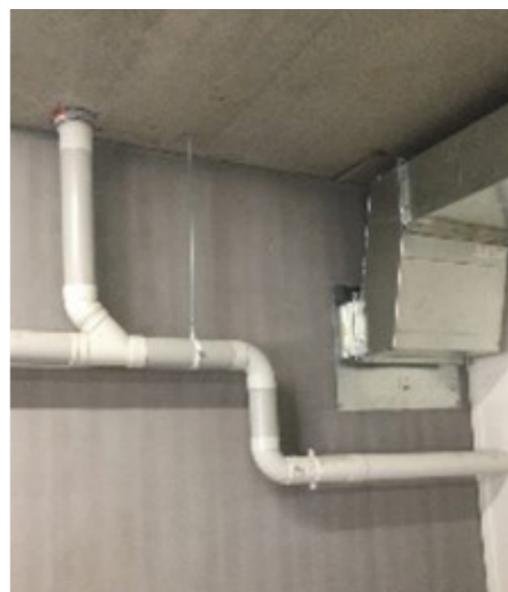
### SANITARY DRAINAGE AND PLUMBING SYSTEMS - THROUGHOUT THE DEVELOPMENT

- Below ground stormwater drains did not have the appropriate depth of cover. AS/NZS 3500.3:2018 Table 6.2.5 or grade AS/NZS 3500.3:2018 clause 6.3.4.
- Suspended sewer does not have appropriate provision for expansion. (AS 2032-2006 Clause 6.4.2.4).
- The drains passing through the footings/walls have not all been appropriately lagged with a suitable material of not less than 25mm. (AS/NZS 3500.2 2018 clause 3.8.2).
- Inspection openings have not been provided for on the below ground sewer where required. (AS/NZS 3500.2 2018 clause 4.7.1)

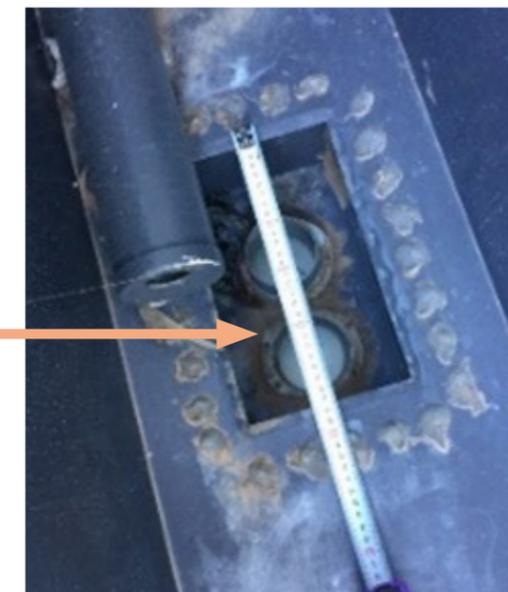
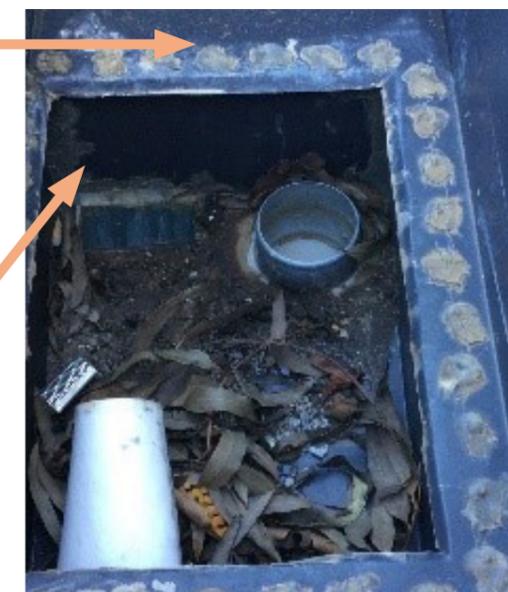
### ROOF DRAINAGE SYSTEMS

- Sumps throughout the development were not appropriately sized in accordance with AS3500.3, with a minimum length of 400mm and when fitted with an overflow device with a depth of not less than 150mm as per HB:2015 cl 5.7.2.
- Throughout the development, high-capacity overflow devices for the sump were not installed to the minimum required height, (S/NZS 3500.3:2018 clause 3.7.7.2)
- Throughout the development, sump downpipes are installed too close to the nearest vertical side of the sump. SA/HB 39-2015 clause 5.7.2 (a)

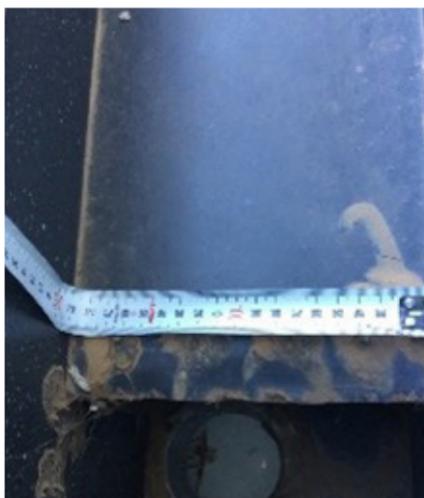
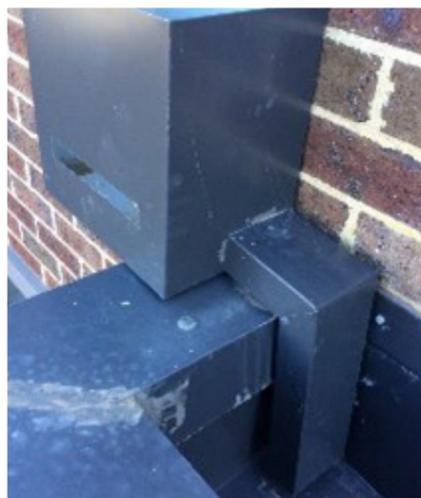
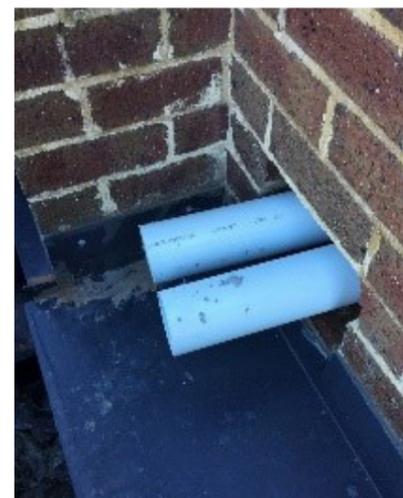
- Box gutters were undersized throughout the development. (minimum 200mm width) A/HB 39-2015 clause 5.3.2 (g).
- Downpipes throughout the development from the upper roof catchment were terminated directly into the box gutter. AS/NZS 3500.3:2018 clause 3.4.

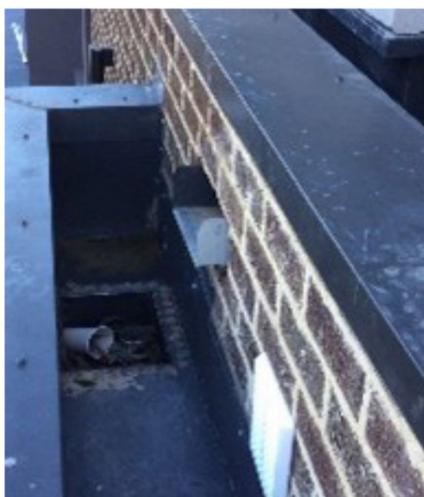
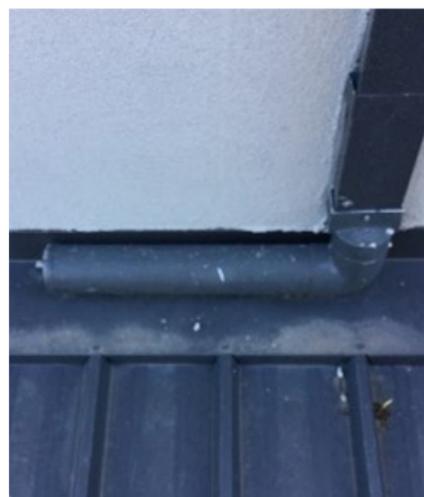
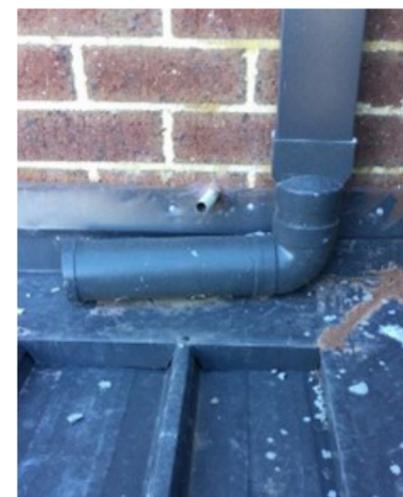
- Throughout the development box gutters do not terminate into an appropriately sized sump or rain head. (side chutes) SA/HB 39-2015 Clause 5.3.3.
- Some spreaders are terminating non-compliantly over flashings and have not been constructed with a half end cap installed. HB 39 2015 cl 5.7.7.

While a medium risk letter, sent by the VBA, resulted in the building practitioner sending photographic evidence of rectified work, the evidence was inconclusive and a re-inspection was undertaken by the VBA.
