Proactive Inspections Program

Activity Report

OCTOBER - DECEMBER 2021

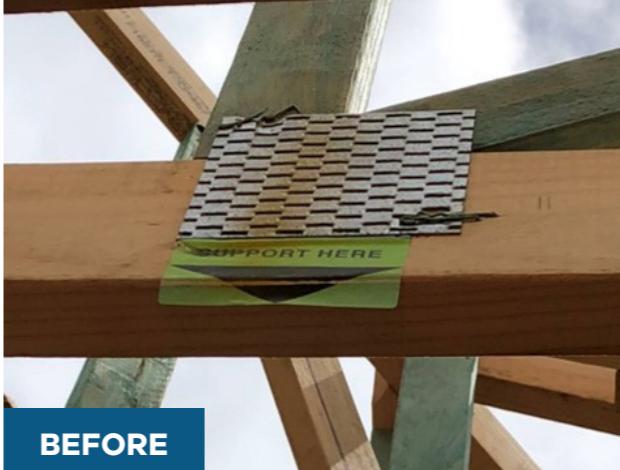
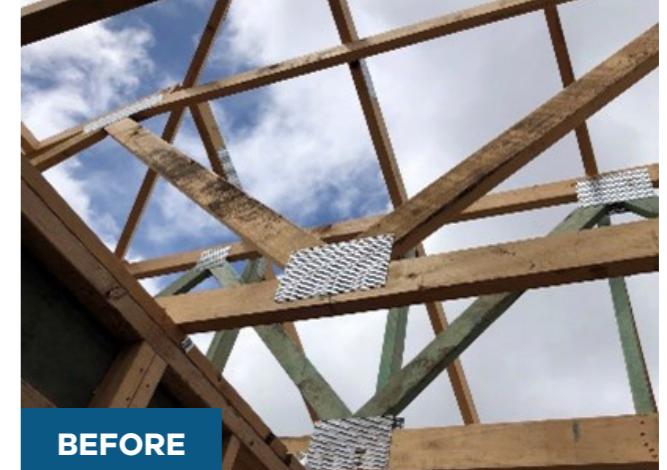
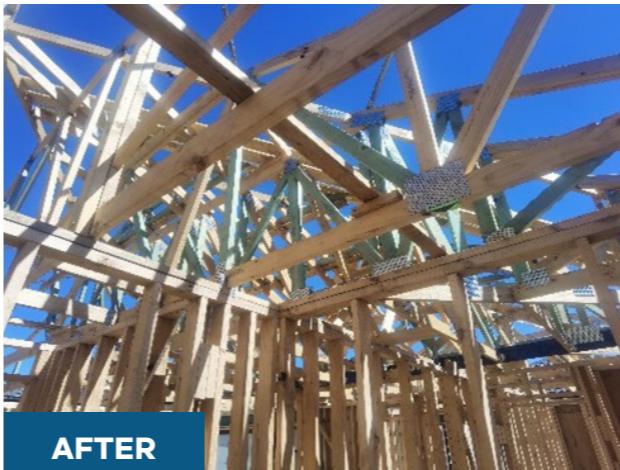
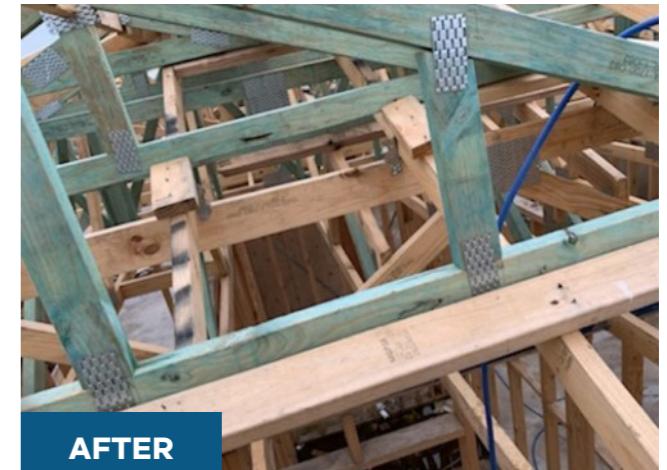
Trusses installed backwards

A VBA notification of medium risk building activity was sent to the builder and RBS. This prompted the builder to have the truss manufacturer/designer review the trusses, provide a rectification detail, and install the missing framing anchors.

The VBA closed the matter after receiving the rectification detail from the truss manufacturer/designer with evidence of the rectified work and the approved re-frame inspection report.

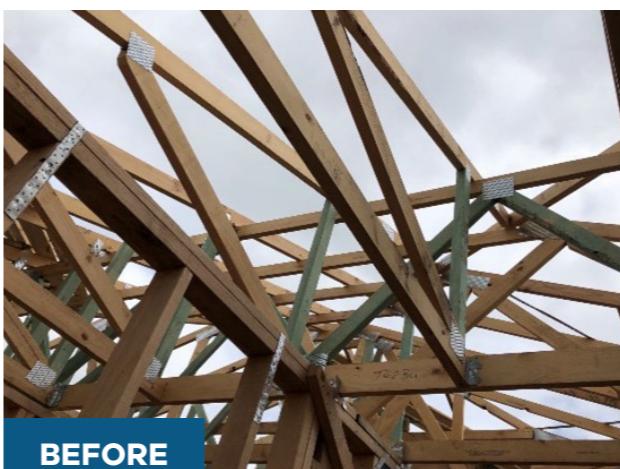
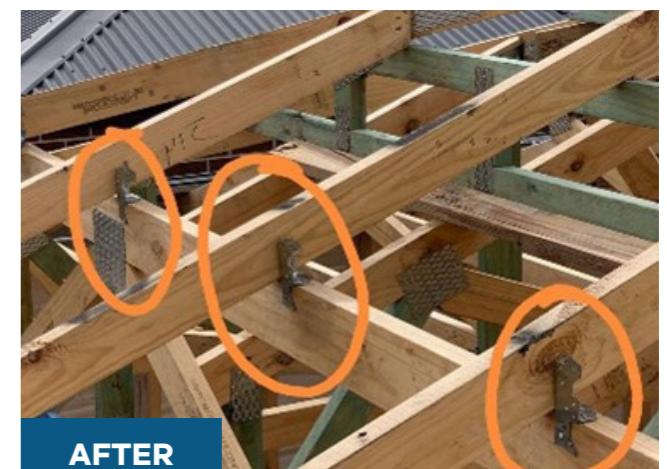
Framing anchor missing between trusses

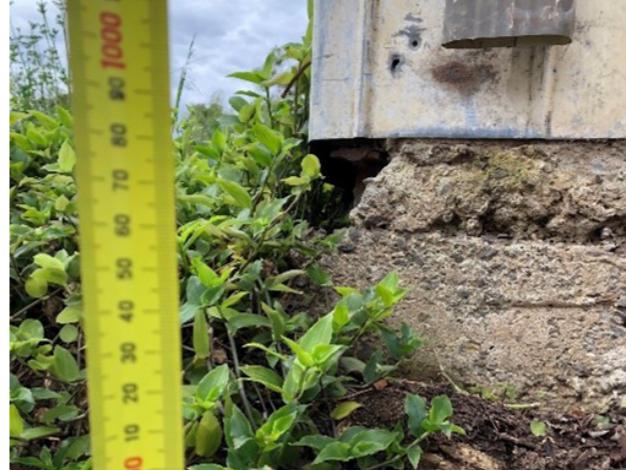
Adjoining property's garage wall undermined by site cut on

The VBA closed the matter after the VBA received notification from the RBS that all remedial works were completed as per the directions to fix and evidence of the underpinning works being completed on the adjoining property's garage wall.

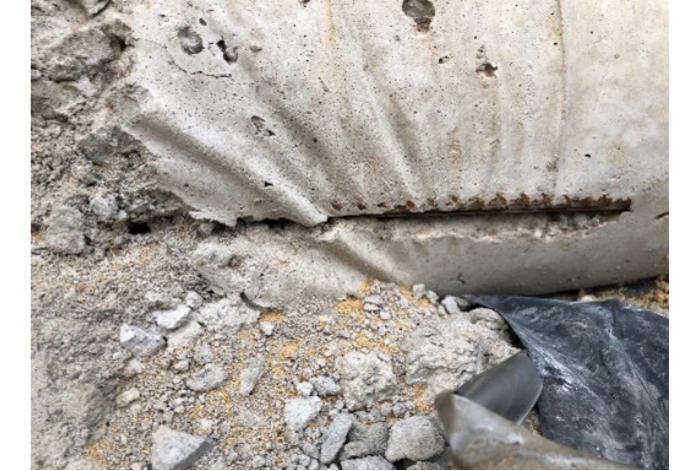
Exposed concrete slab steel reinforcement

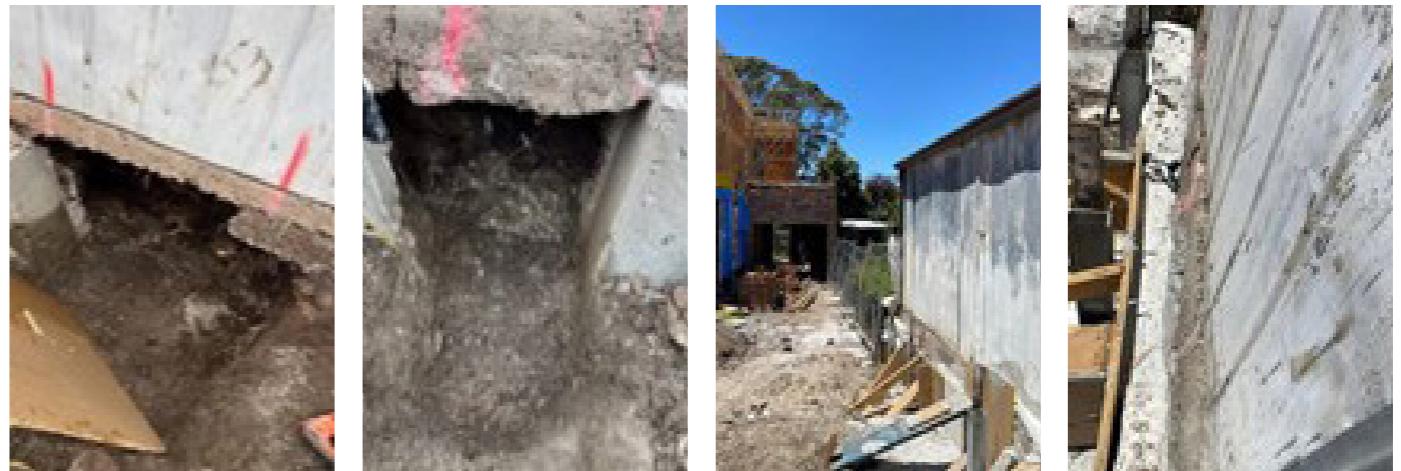
Underpinning of the undermined garage wall

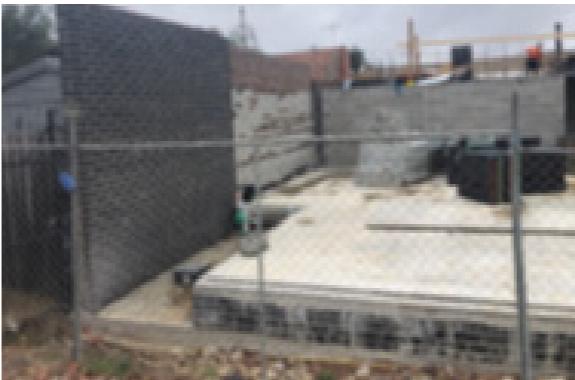
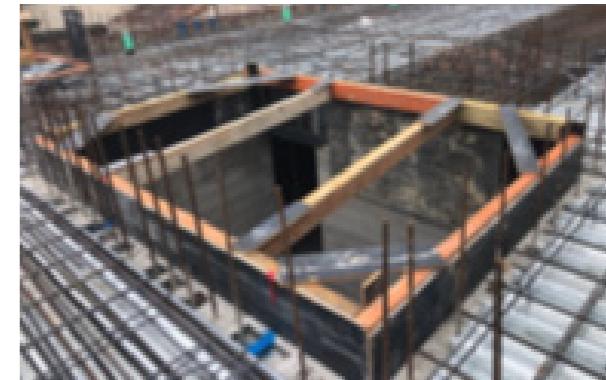
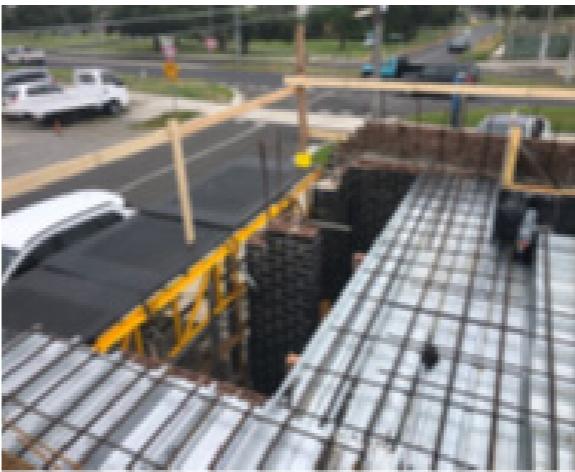
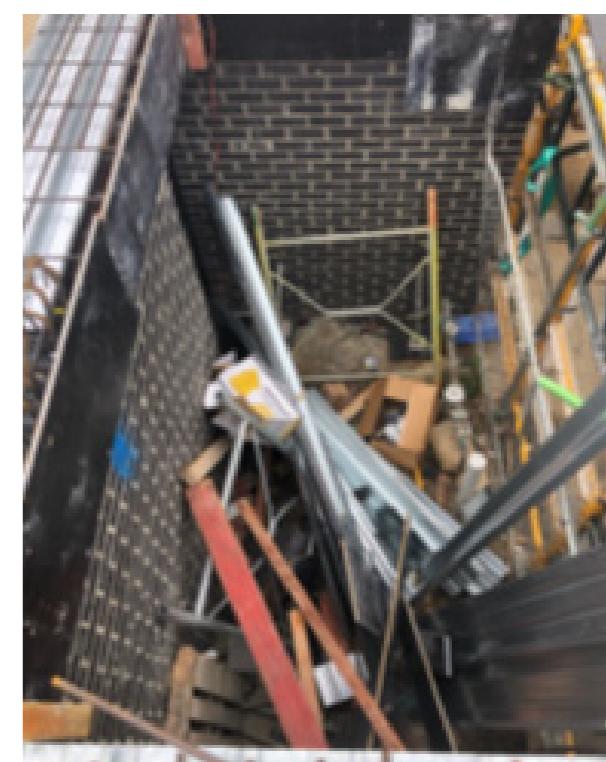
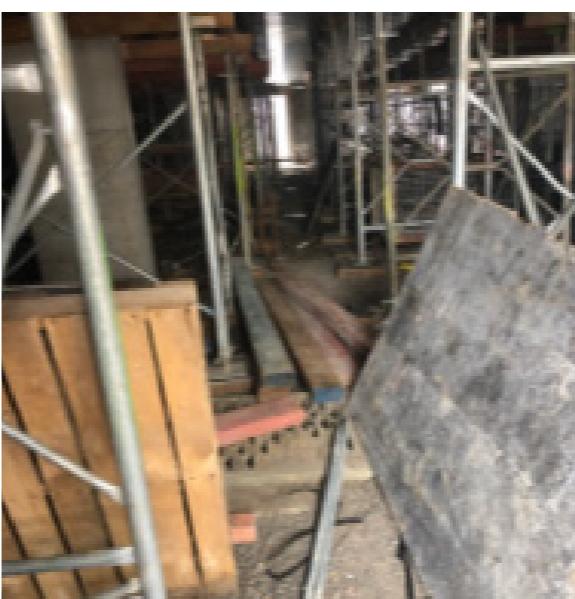
- Absence of fall protection areas greater than 2.0 m were found throughout the site.
- Poor housekeeping and rubbish including a toilet that was not fit for purpose nor clean at time of inspection.

- Storage of materials throughout the site did not provide for safe egress paths in accordance with Occupational Health and Safety requirements for workers on building sites.

- Absence of fire extinguishers at the time of the inspection. A requirement under NCC:2019 Volume One, Section E1.9 for fire precautions in buildings of Class 2 and above to be in place during construction.

The VBA referred the matter to WorkSafe, and a VBA notification of high-risk building activity was sent to the builder. The builder took immediate action to rectify the issues, which included installation of handrails on all exposed voids and edges and the temporary propping of the free-standing masonry.

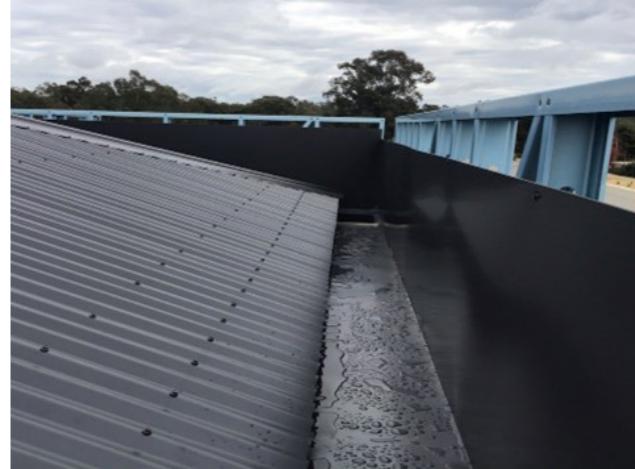
Box gutters fixed to the structure

While some items were rectified, three items (all related to the box gutter) remain non-compliant and the roofing practitioner chose to lodge a Certificate of Compliance for the works. This certificate was then audited under the VBA's Plumbing Audit Program, and the three items related to the proactive inspection were identified.

The Roofing Practitioner has been issued a Rectification Notice and the case remains opened.

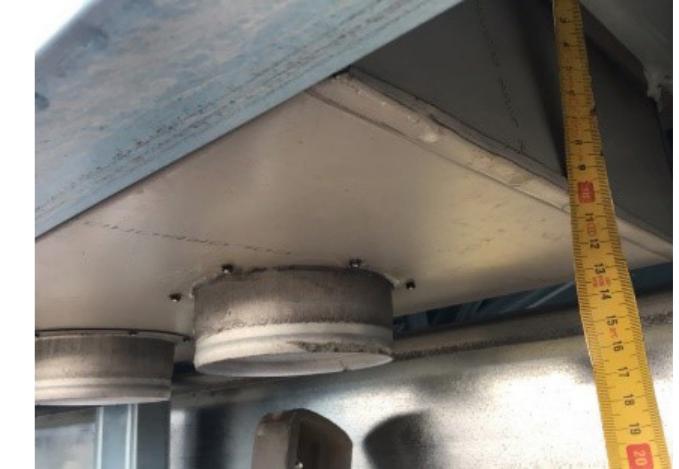
Undersized high capacity sump

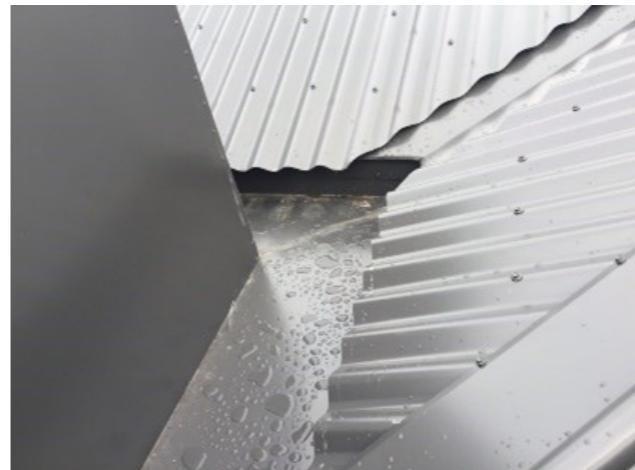
Change of direction in a box gutter

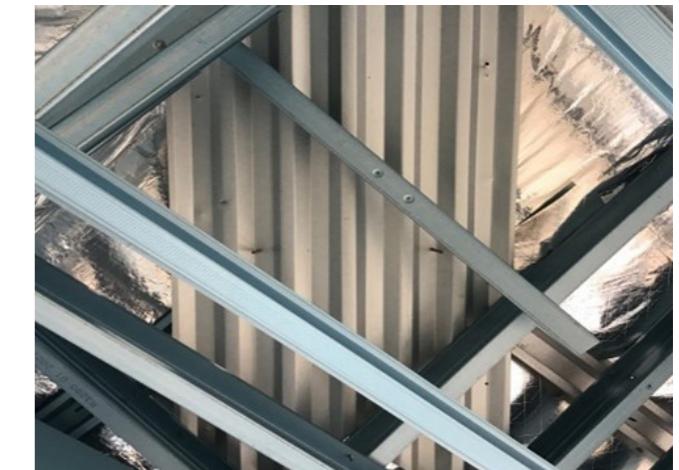
Valley gutters fixed to the structure

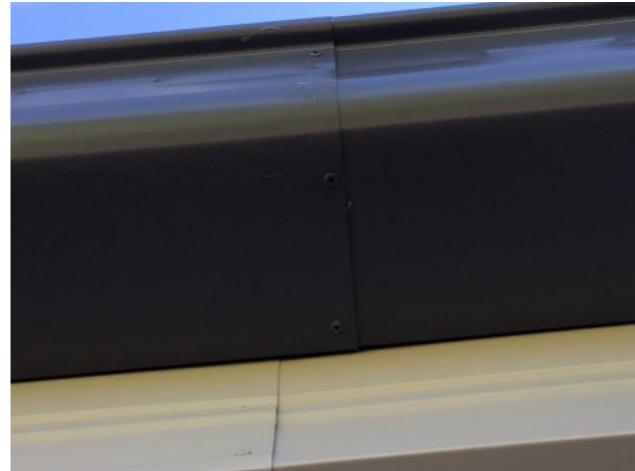
Insufficient fastening of eaves gutter joints

After much discussion amongst the VBA inspector, builder and licensed roofing practitioner an understanding was reached between all parties of what was required to achieve compliance.

Modifications were made to the structure of the dwelling and the volume builder confirmed the design of this dwelling has been altered to ensure compliance of valley gutters can be achieved for any future builds.

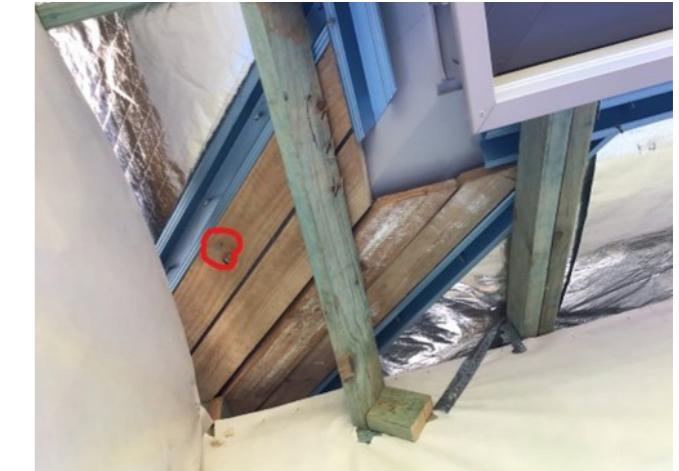
Valley gutters fixed directly to the structure

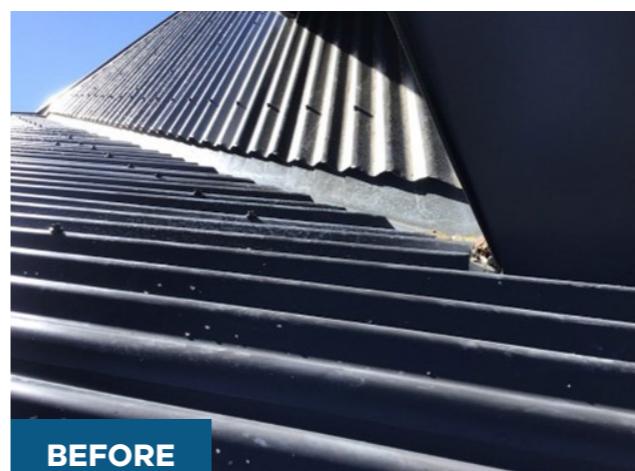
Valley gutters not discharging into an eaves or box gutter appropriately sump
