# PROACTIVE INSPECTIONS PROGRAM

## Activity Report

FINANCIAL YEAR 2021/22

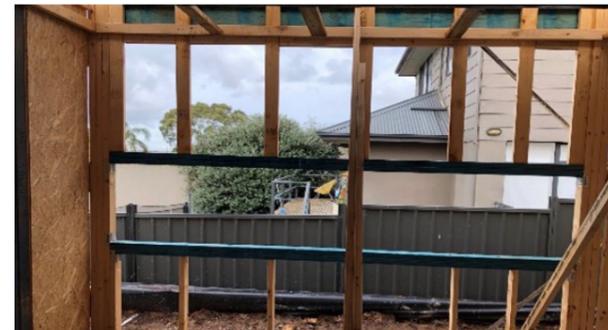
##### Overlooking

A proactive inspection of a double storey dwelling in Greater Melbourne, found the kitchen window was overlooking on to adjoining neighbours secluded private open space and directly into habitable room windows.

The VBA contacted the RBS who reported that the nominated adjoining property's fence height, (2.45m on the plan), was not consistent with the actual height of the fence and that he will ensure suitable measures to prevent overlooking will be enforced. The VBA closed these matters after receiving confirmation the existing fence will be replaced by a 2.45m fence, to comply with the siting requirements.

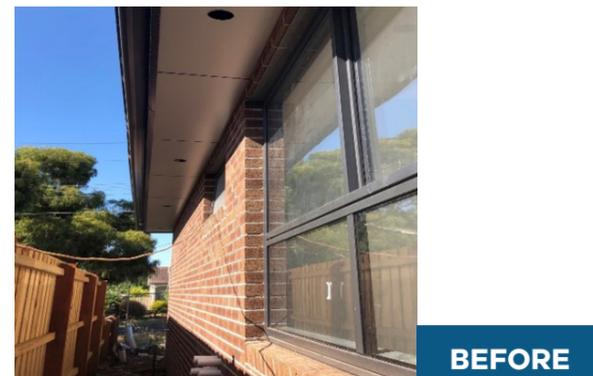
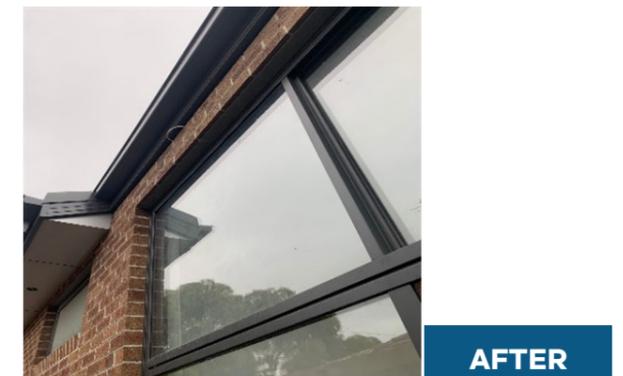
##### Daylight to habitable room windows

A proactive inspection of a single storey dwelling in Greater Melbourne, found that daylight to habitable room windows had not been achieved along the side of the dwelling where the eave, fascia and gutter reduced the clear to sky dimension to less than 1m. The VBA contacted the RBS who reported the eaves were not constructed in accordance with the plans which did not have the eaves overhanging the windows. The VBA closed the matter after receiving photographic evidence the eaves were removed above the windows.

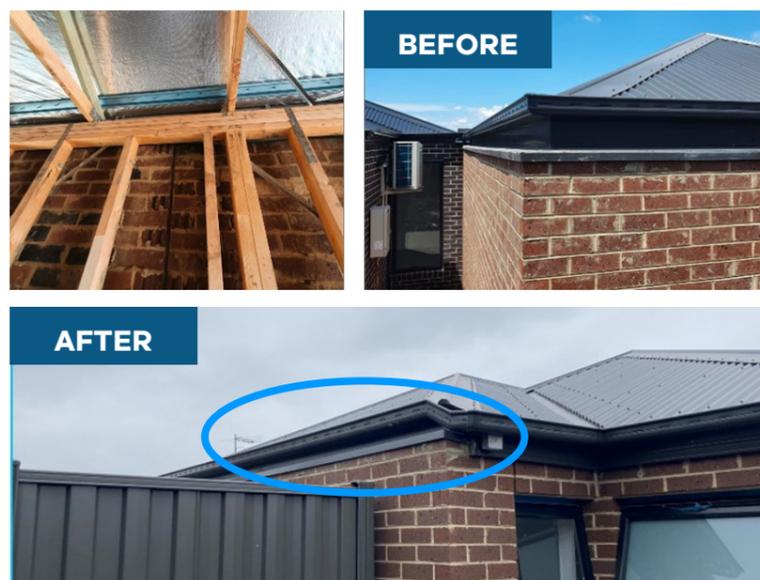
A proactive inspection of a new single storey dwelling in Greater Melbourne found timber/EPS cladding on the property boundaries that were not protected with fire resisting material. Additionally, the brick veneer fire resisting walls, constructed within 900mm of the property boundaries, terminated 300mm from the underside of the non-combustible roof covering; Part 3.7.2 of BCA (Volume 2) requires a gap of no more than 200 mm. The photos relate to the garage wall and rear wall of the dwelling.

*Additional brickwork*

The VBA contacted the RBS and builder to rectify the issue and the VBA closed the matter upon receiving photographic evidence of additional brick work, (to raise its height and reduce the gap between the capping and gutter to less than 200mm), and fire resistant material added.

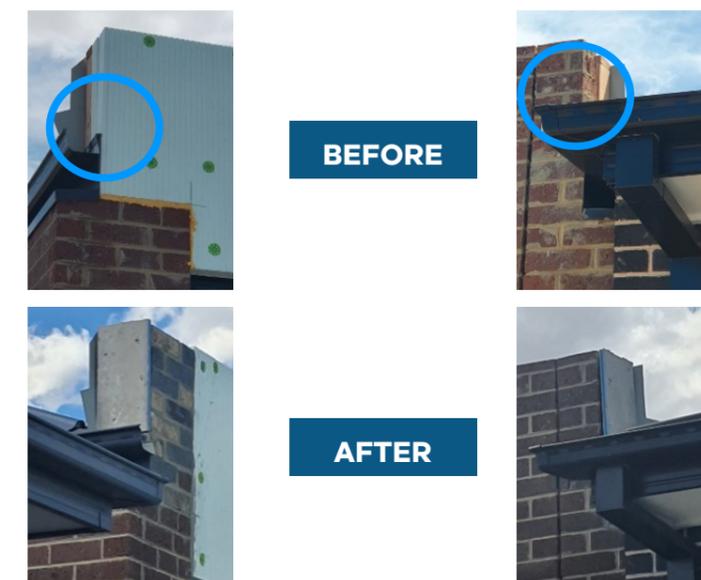
*Fire resisting material added to the timber/EPS cladding on the boundary*

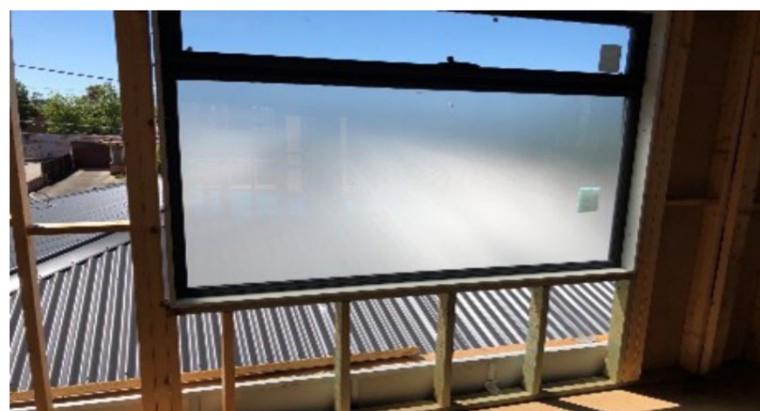
##### Window proximity

A proactive inspection of a multi-unit development in Greater Melbourne, observed windows located within 1.8m of another building on the same allotment without being protected in accordance with Part 3.7.2.4 of BCA (Volume 2).

The VBA contacted the RBS and builder to rectify the issue and the VBA closed the matter upon receiving the RBS approved revised design of the dwelling.

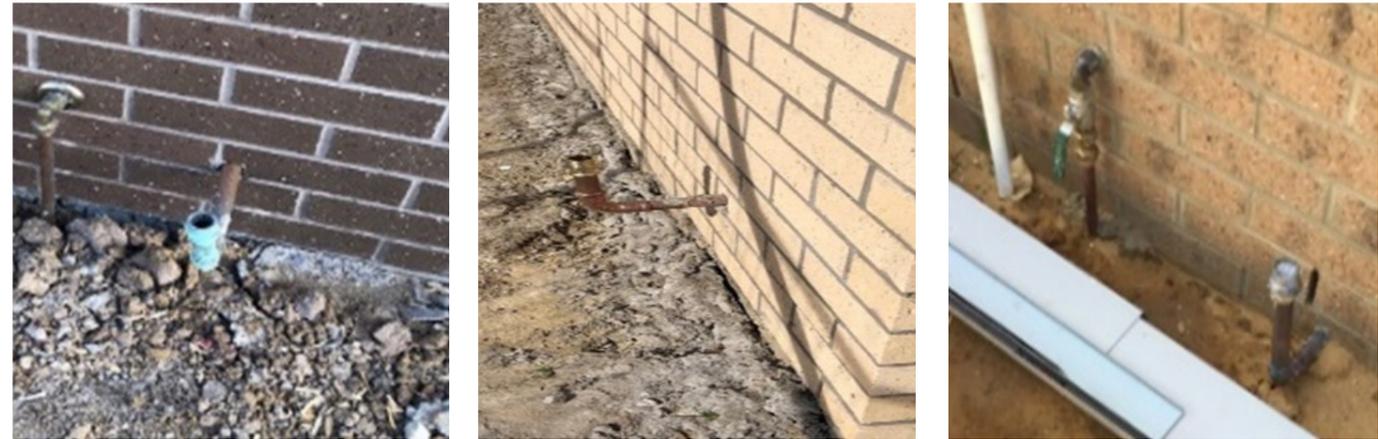
*Compliant termination/entrance points for gas and water*

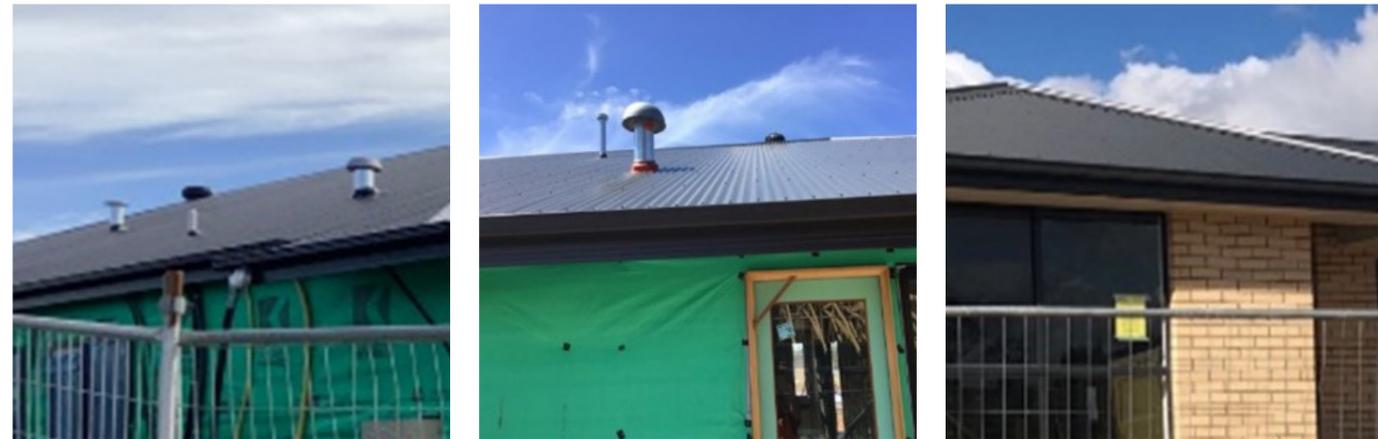
*Roof cladding, gutters and penetrations*

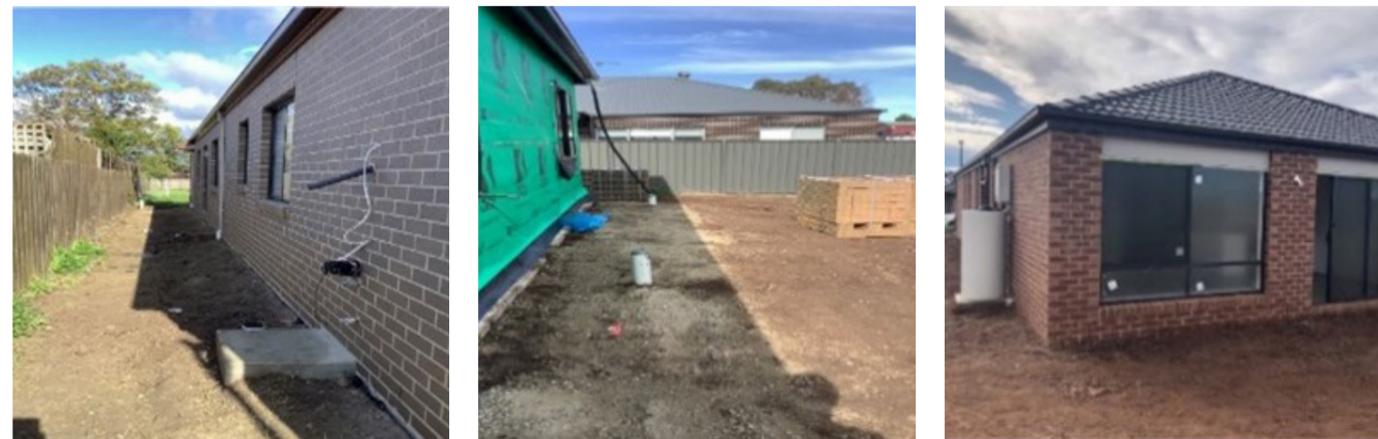
*Tidy work sites at various stages of construction*

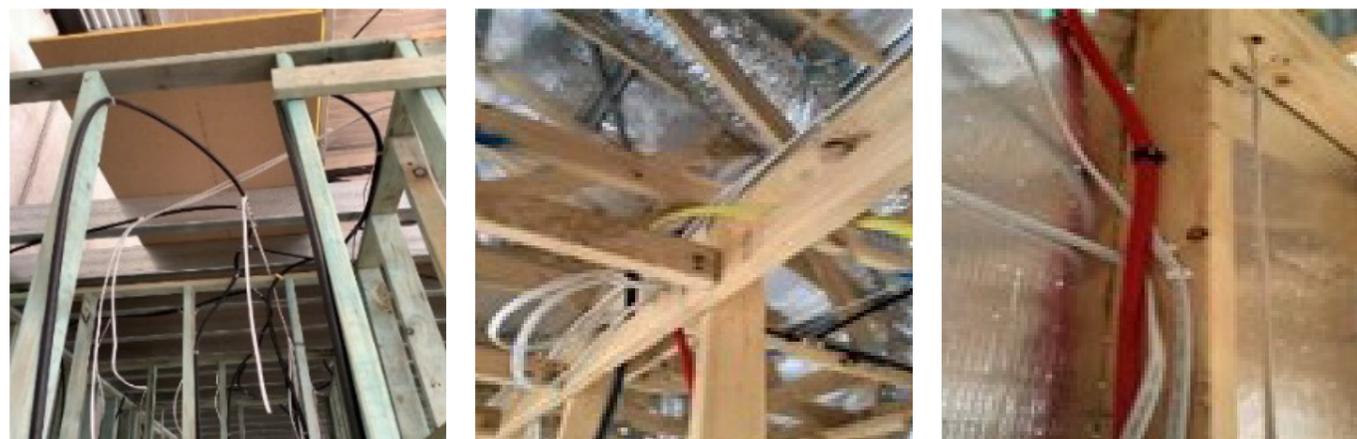
- Insufficient separation of services is often caused by other trades such as electricians. The VBA urges building practitioners to ensure the responsible trades are aware of the requirements to achieve separation.

### *Insufficient separation of services from electrical wiring installations*

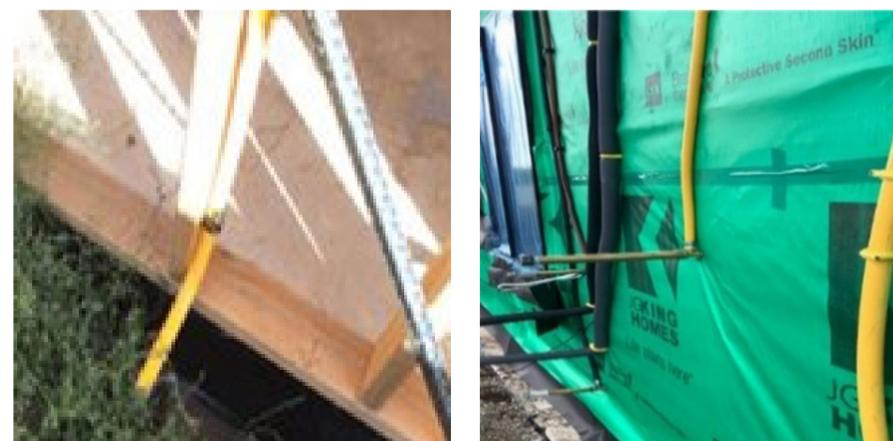
### *Multi layer gas piping (yellow pipework) exposed to UV unprotected.*

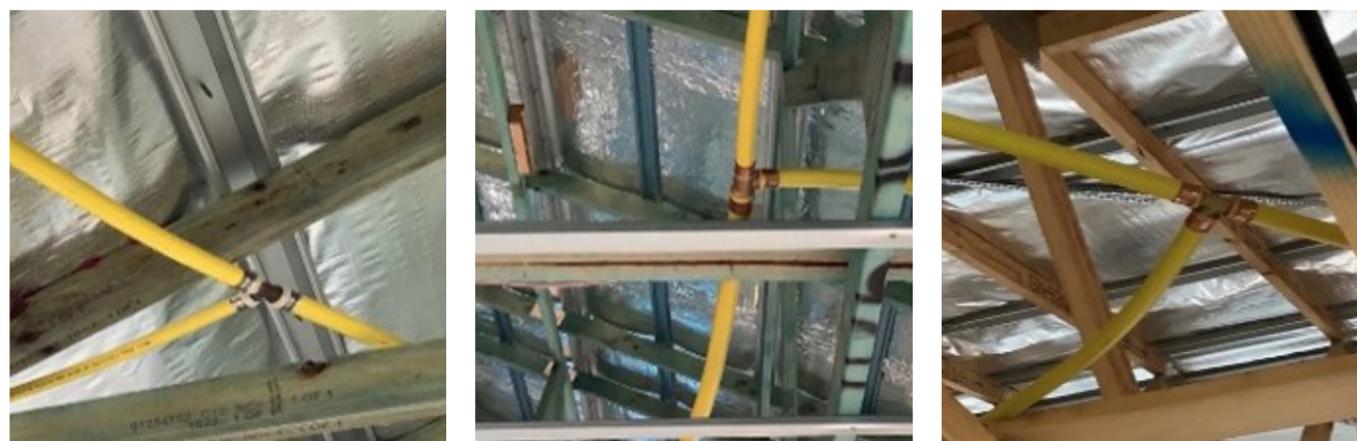
### *Omission of reversion fittings on multi layer gas piping installations*
