# Proactive Inspections Program Activity Report

JULY - SEPTEMBER 2021

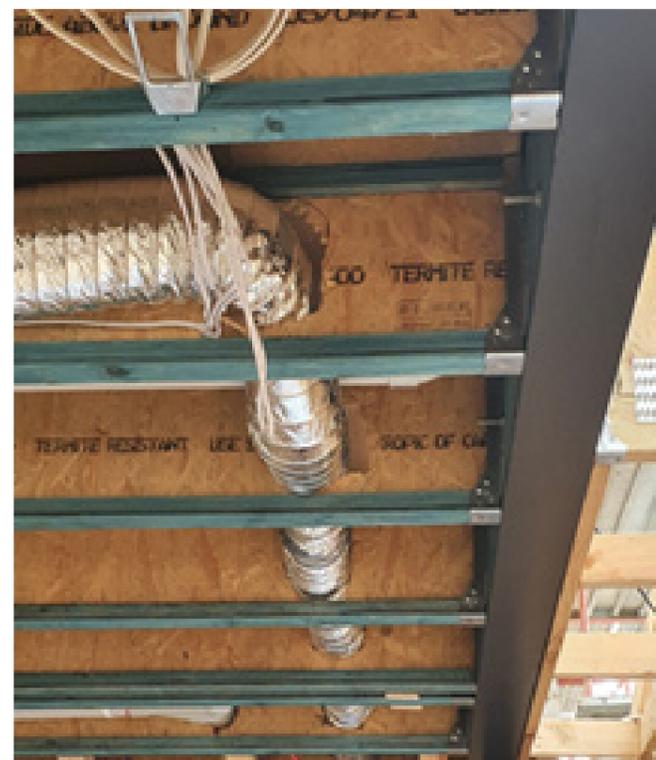
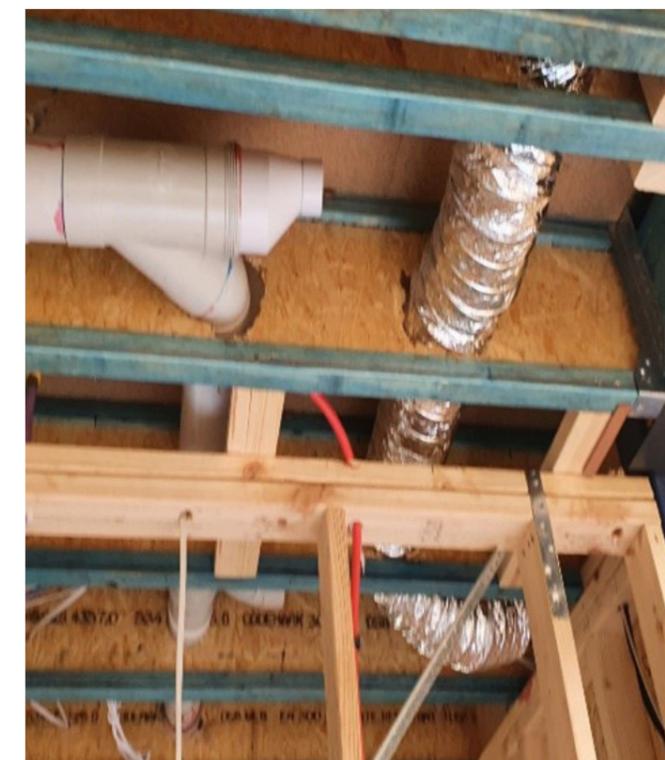
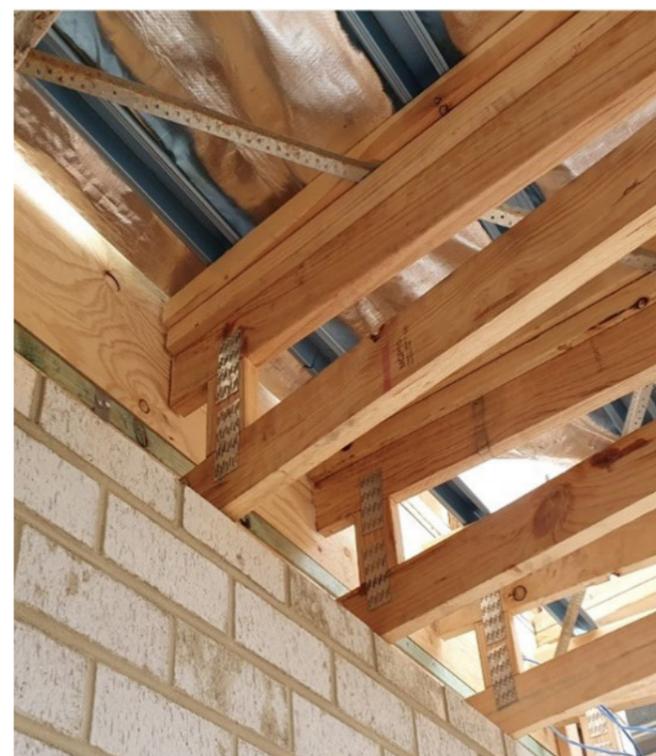
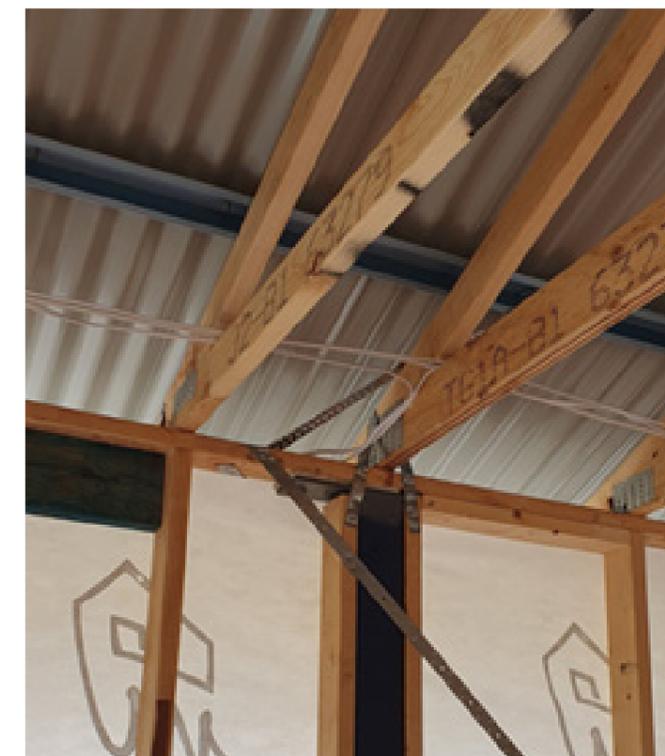
A proactive inspection identified several structural framing issues. Various I-Joists were found to have excessive holes that exceeded tolerances permitted by the manufacture; holes had been made within 660mm of the ends and were too close together. The top cord of the roof trusses over the front porch were also missing fixings.

The VBA closed the matter after receiving comprehensive photographic evidence of the rectified work from the builder and the engineer's report for the repairs.

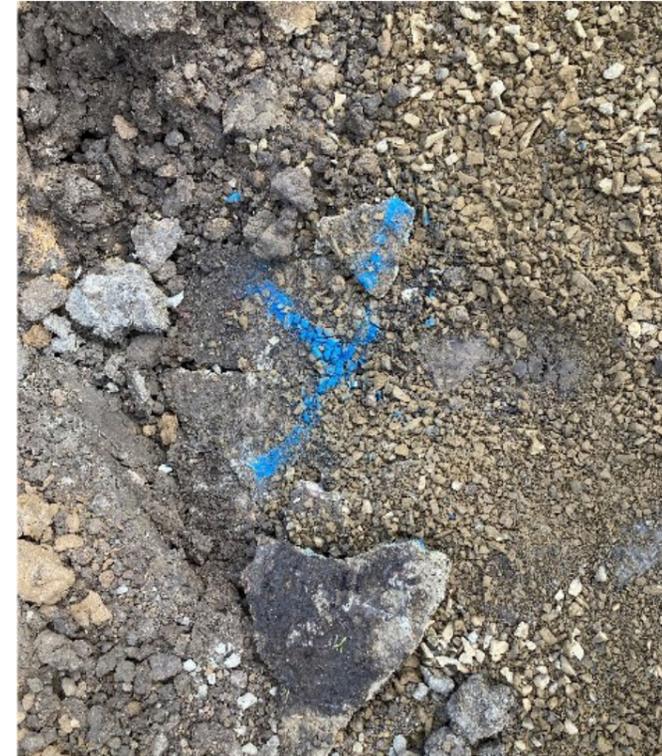
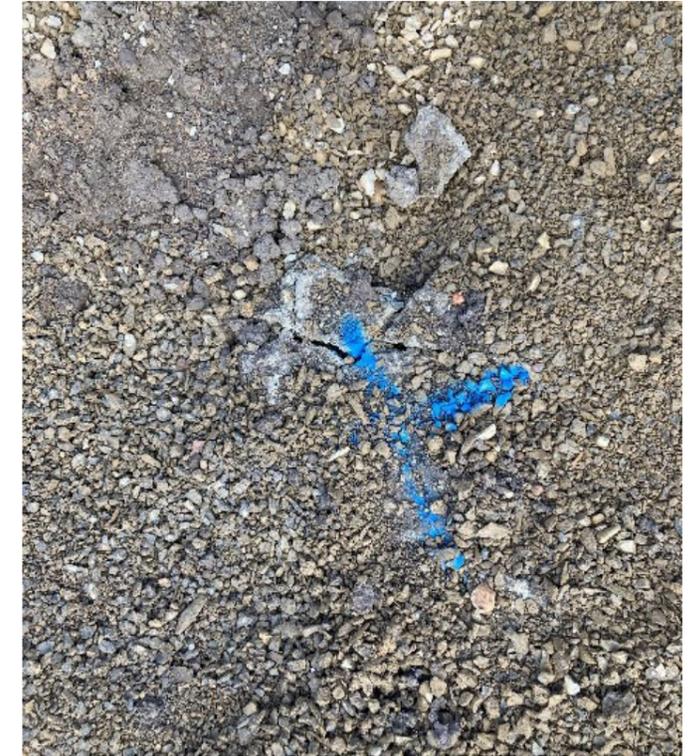
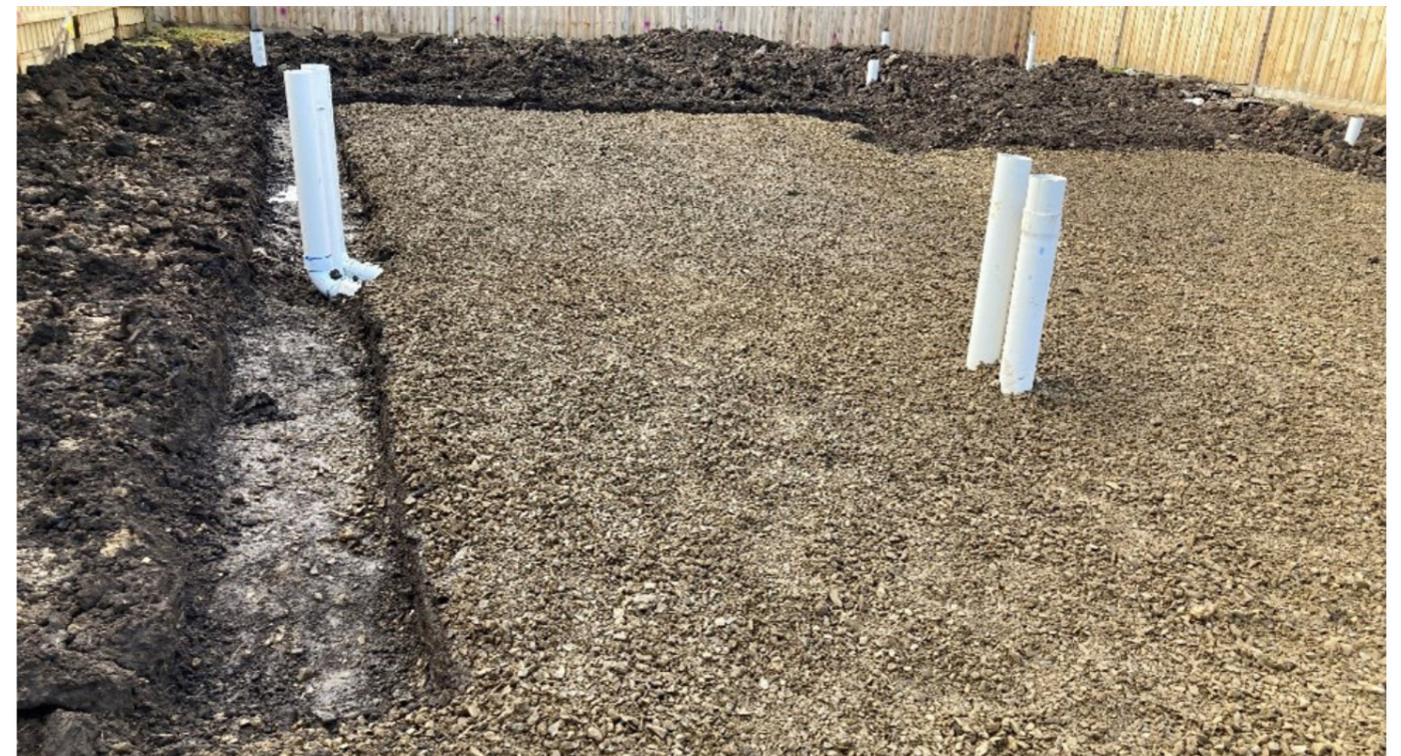
### Footings and edge beam construction compromised

A proactive inspection identified cracks in piers poured to the depth of 50mm and service pipes located within an edge beam reducing the beam width.

The piers were unable to be justified and were subsequently removed as a result of the inspection. New piers were installed and the service pipes were relocated, all of which were re-inspected by the VBA to ensure compliance was being achieved on site.

The VBA closed the matter after receiving the relevant mandatory inspection reports and photographic evidence of the rectification process.

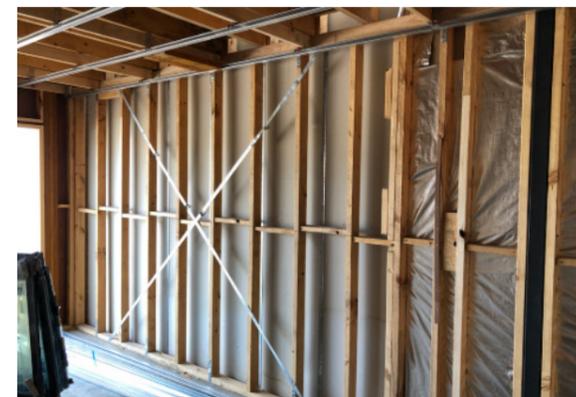
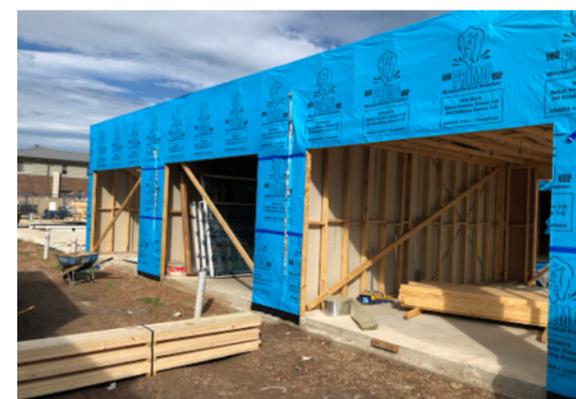
Shaft liners not installed as per manufactures requirements.

The VBA closed the matter after receiving a range of documents from the RBS that included a fire engineering report, inspection records from the RBS and an amended building permit.

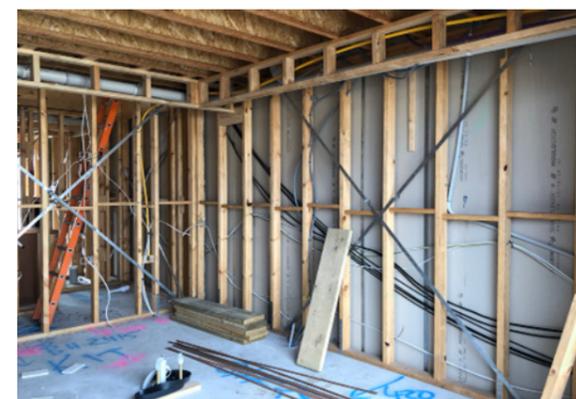
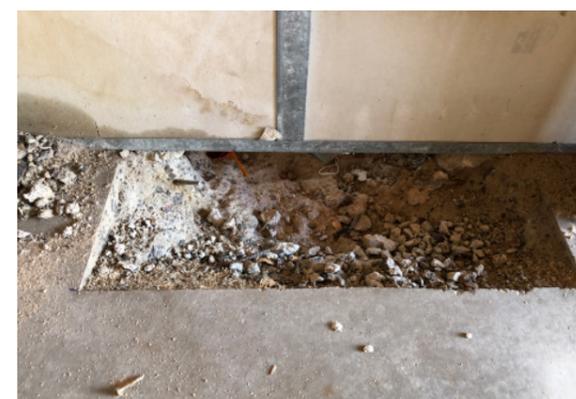
Additionally, the RBS did not list a mandatory inspection relating to fire and smoke (Regulation 172) of the Building Regulations 2018 on the Building Permit and the concrete slab had been broken/cut removing and exposing the slab mesh in one of the apartments.

Concrete cut exposing the slab mesh.

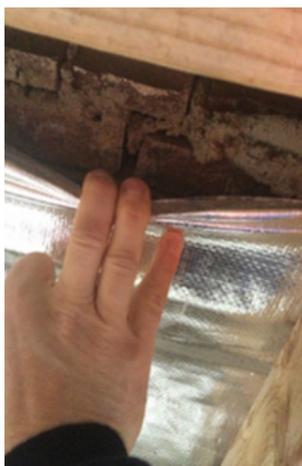
- No sill flashings were installed to openings in masonry veneer walls, contrary to NCC Volume 2 2019 clause 3.3.5.8.

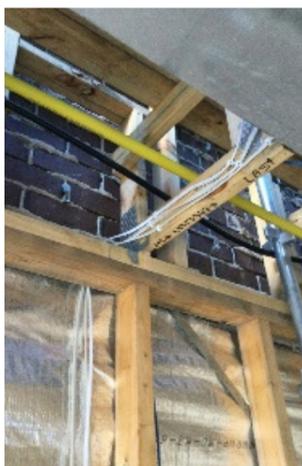
- Wall ties were not attached to the timber frame, contrary to NCC Vol 2 – clause 3.3.5.10

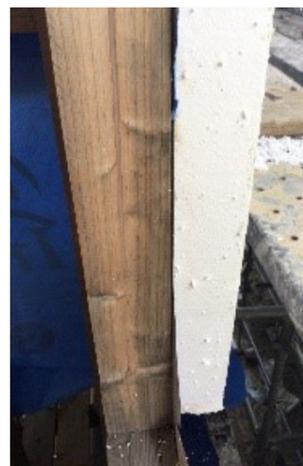
- EPS used as the external cladding was not installed in accordance with the manufacture's installation manual.

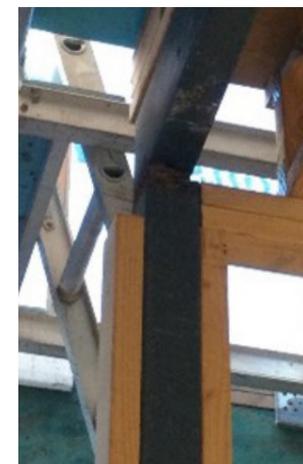
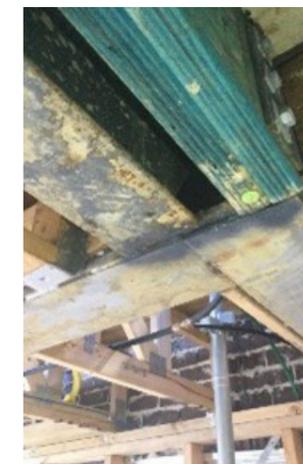
- Welding of structural steel members on site was substandard and in contravention of AS/NZS 1554.1.

VBA has requested the engineer to inspect and approve all welds carried out on site.

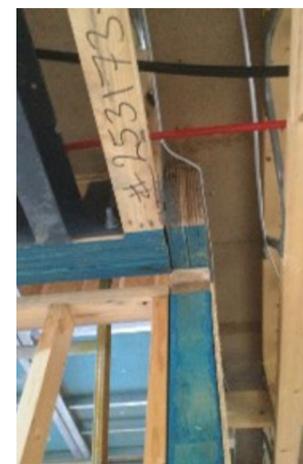
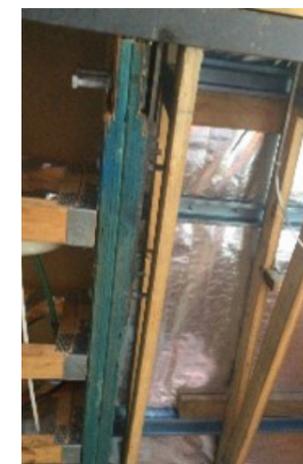
- Connections of structural members were not in accordance with approved engineer's design.

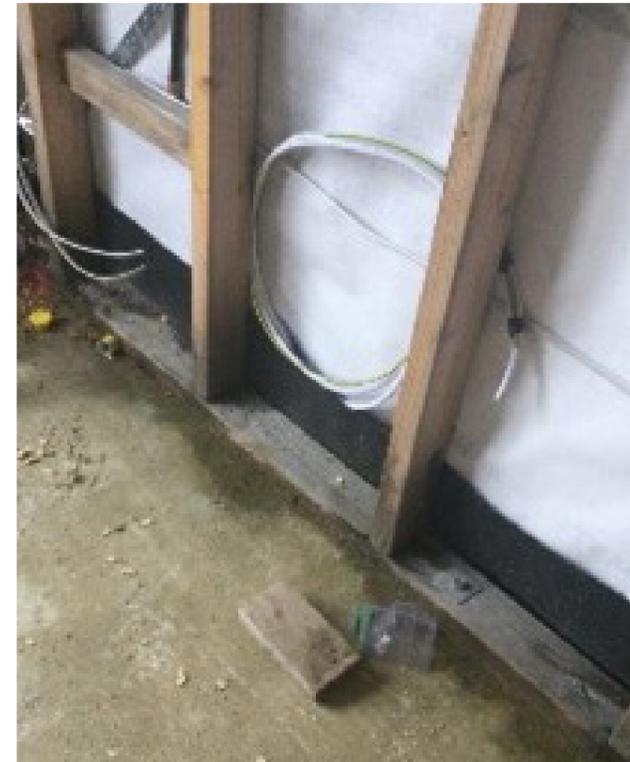
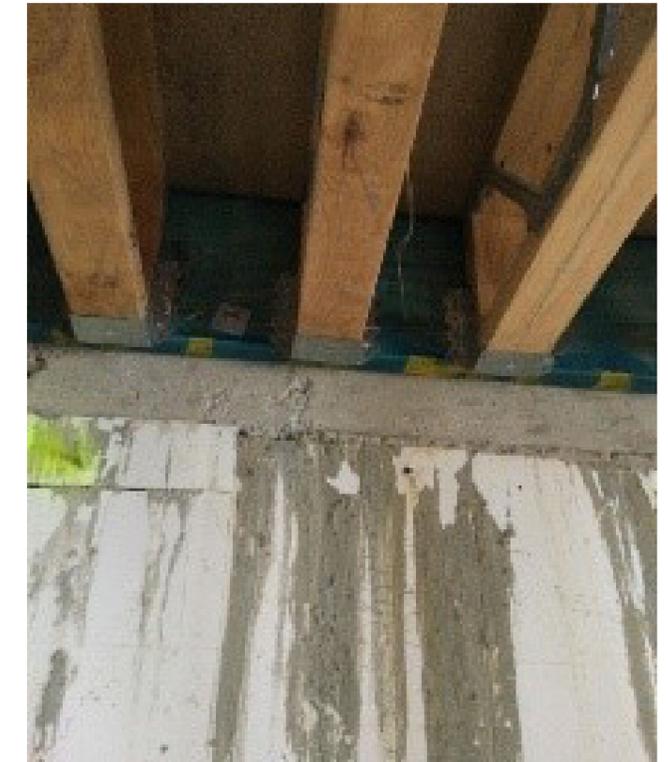
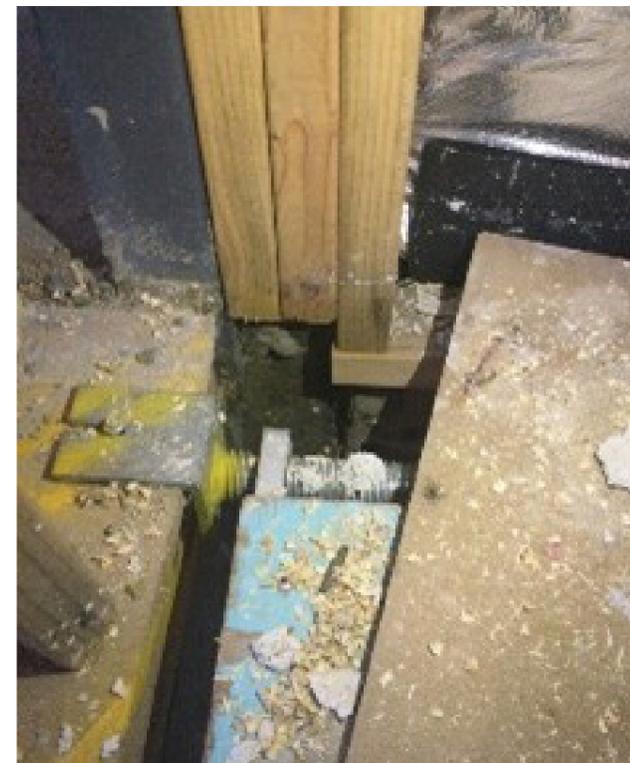
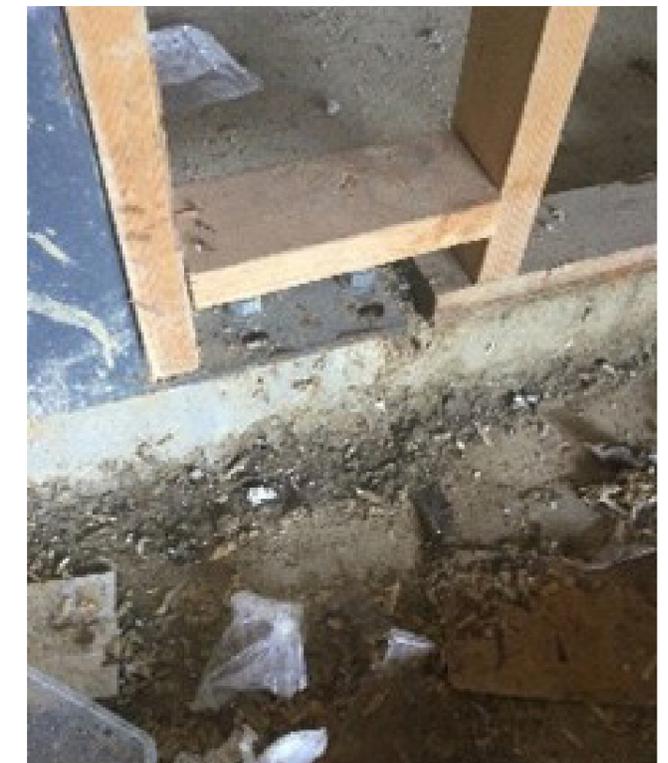
- Specified timber beam in master bedroom and bedroom two are missing in unit one.
- Timber frame throughout all units were exposed to excessive wetting with mould growing in parts.

- Joist hangers were missing to some posi-strut floor trusses throughout all units, contrary to approved posi-strut floor layout.
- Load transfer blocks and stiffening blocks were not installed to support concentrated loads (point loads, jamb studs to openings exceeding 1200mm) between first floor to ground floor supports, contrary to AS1684.2 clause 6.2.2.2 and floor truss installation manual.

- Waling plates were installed to support posi-struts floor trusses and beams supporting floor loads, contrary to engineers design.
- Part of wall frame adjacent column is unsupported.

- Base plate over hanging concrete slab, no structural grouting was installed under baseplates.
- Bolts to steel base plates were not tightened.

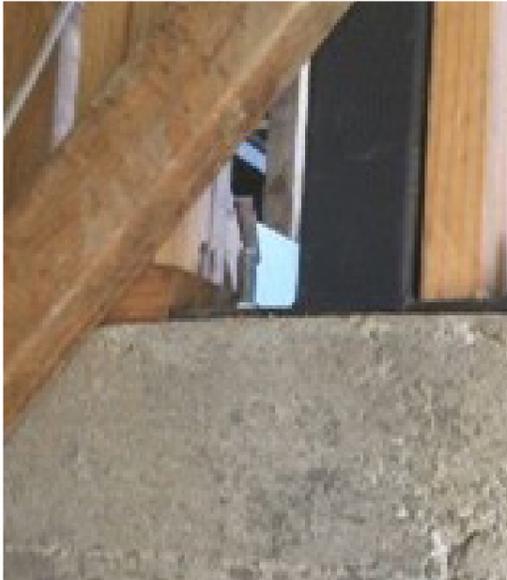
- Suspended slab adjacent to garage was poorly compacted and reo exposed, contrary to AS 2870-2011.

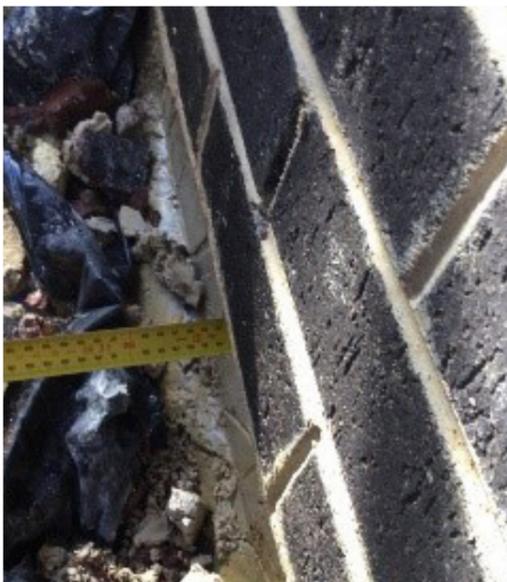
- Brick overhanging edge rebate of approximately 40mm was observed along the west side of unit four, contrary to NCC Vol 2 clause 3.2.2.7.

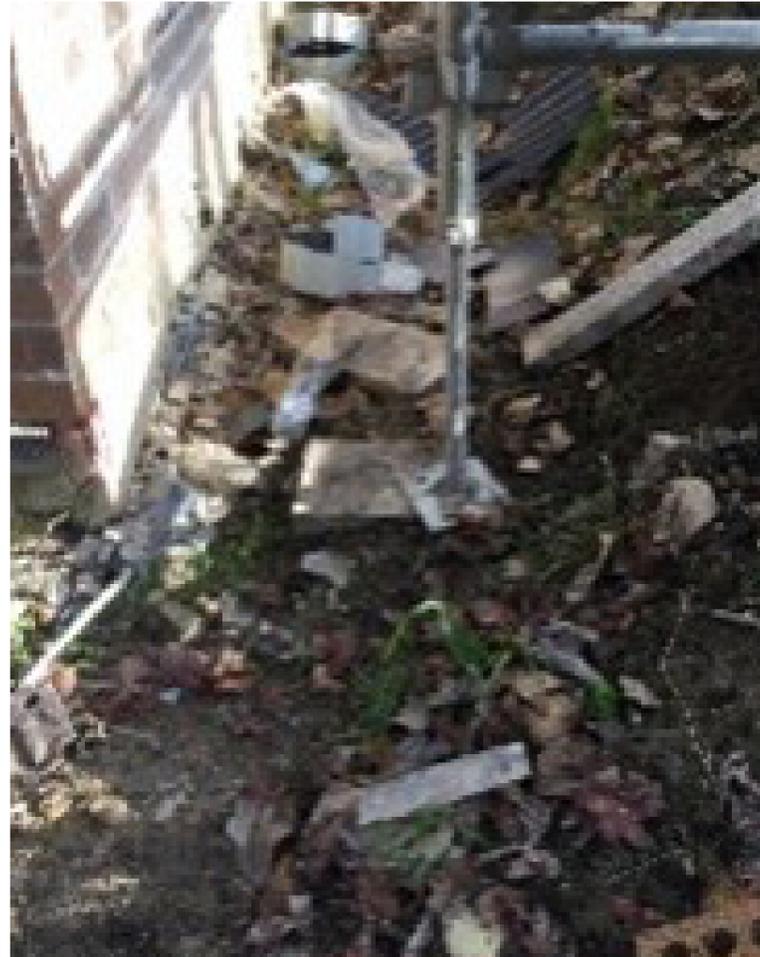
- No retaining structure was installed to North side of unit six, contrary to approved engineers design.

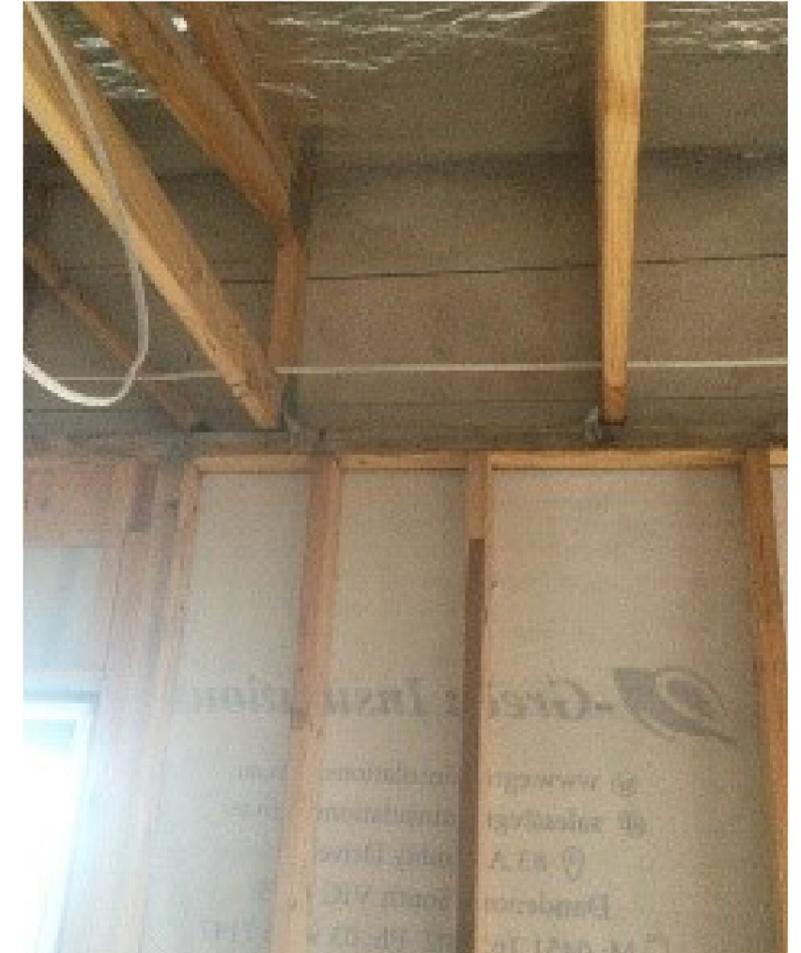
- Pliable building membrane was not installed in all external walls throughout all units, contrary to NCC Vol 2 clause 3.8.7.2.

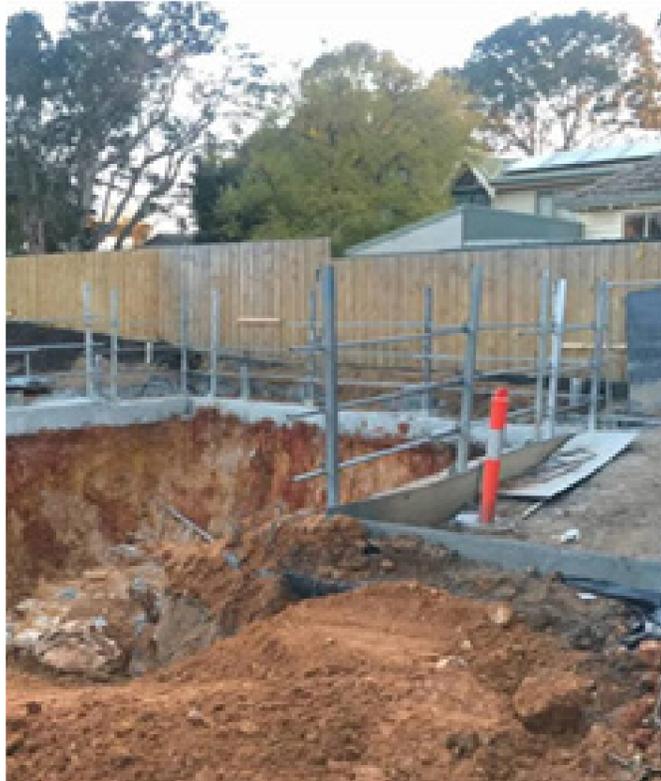
**BAYSIDE**

The proactive inspections team carried out an inspection of four properties undertaking alterations to the dwelling and addition of swimming pools. It was found that swimming pools had temporary fencing however, the temporary fencing was unsecured, allowing young children to access the swimming pool area.

Rectification works were completed within one or two business days.

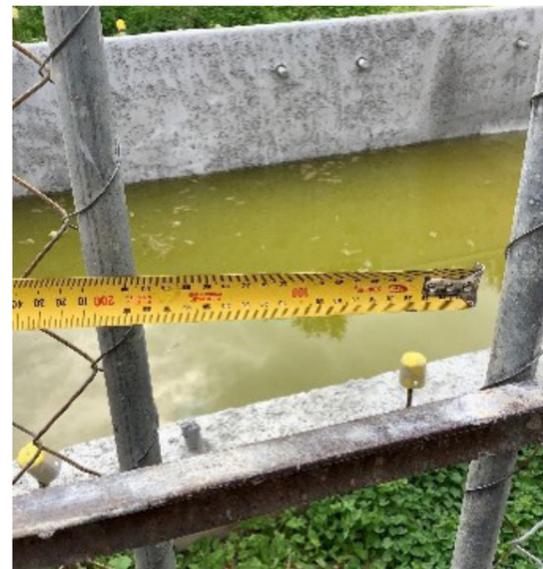
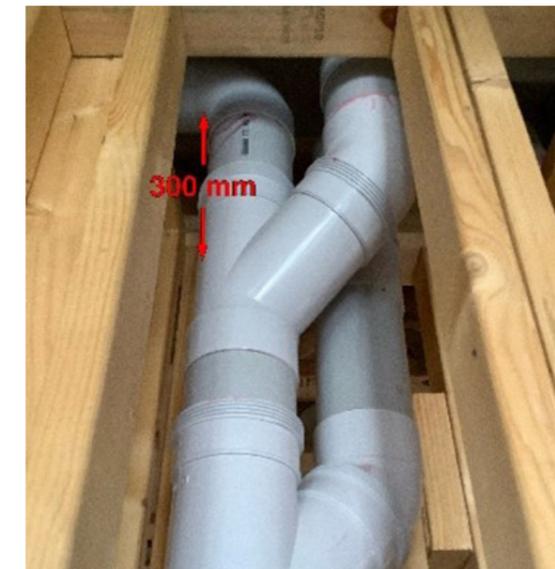
Non-compliant sewer stack branches (AS/NZS 3500.2:2018 clause 9.8.5.)

The VBA closed the matter after receiving comprehensive photographic evidence of the rectified plumbing work.

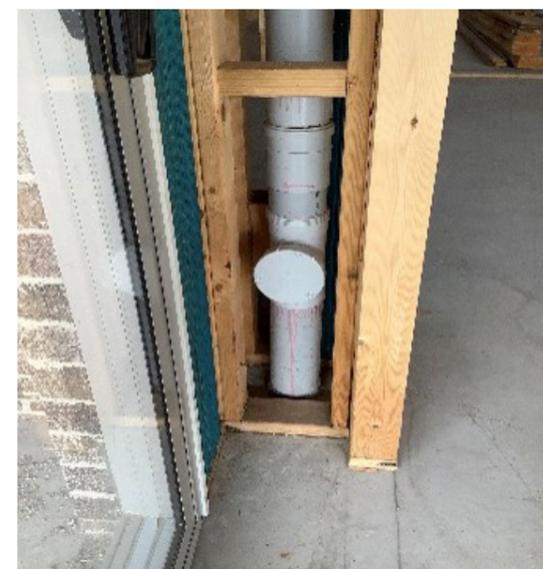
Non-compliant expansion assembly (AS/NZS 2032 2006 cl 6.4.4. AS/NZS 2032 2006 cl 6.4.2.4 (a))

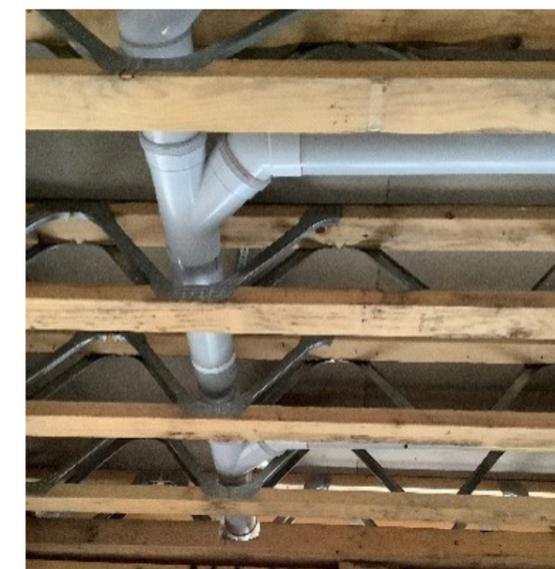
Non-compliant suspended sewer (AS 2032-2006 Clause 6.4.2.4.)

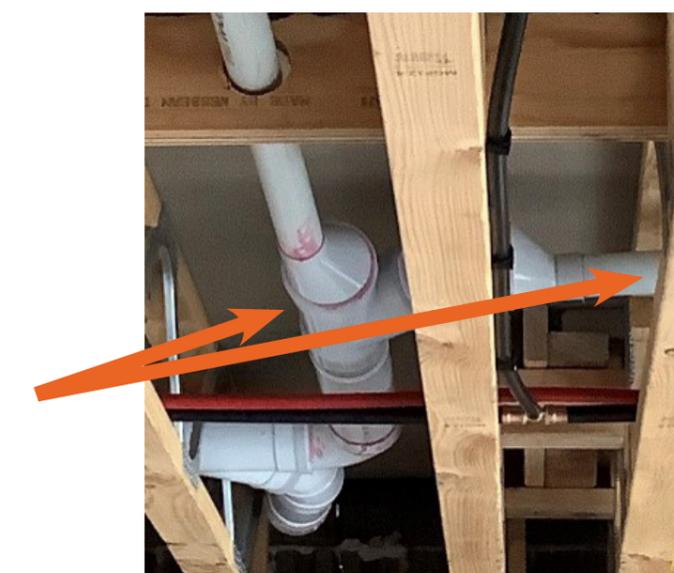
Non-compliant L.I.T fittings (AS/NZS 3500.2 2018 cl 6.6.2.1.)

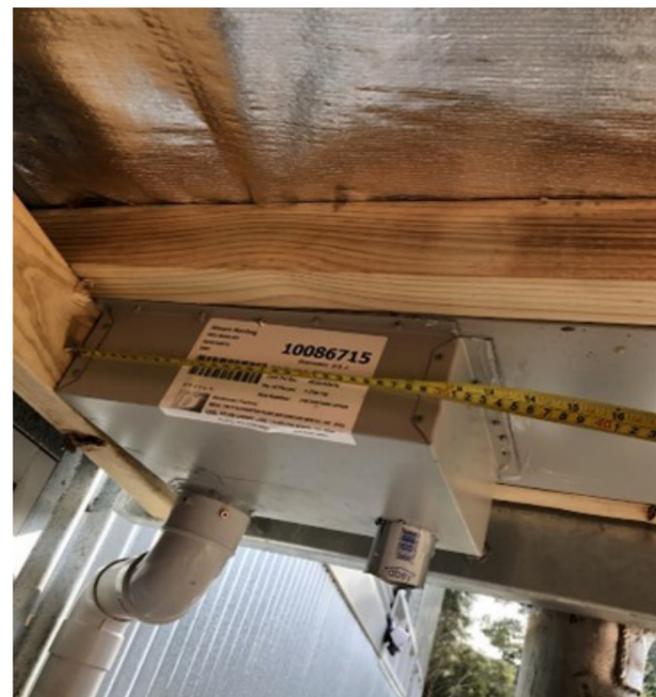
Undersized sump as per HB39 2015 cl 5.7.2 and inadequate overflow provisions as per HB39 2015 cl 5.3.1 and AS/NZS 3500.3 2015 cl 3.7.6

The VBA closed the matter after receiving comprehensive photographic evidence of the rectified plumbing work.

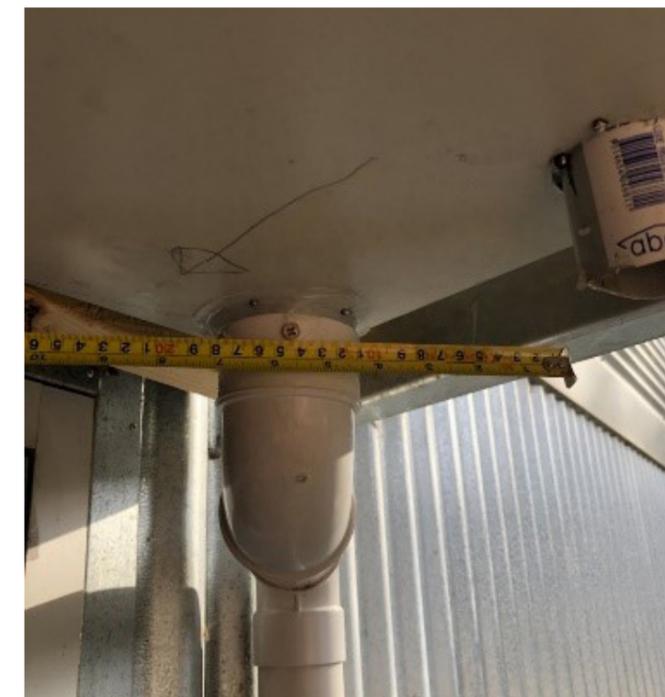
Sump is below the minimum required size (AS/NZS 3500.3 2018 cl 3.7.8)

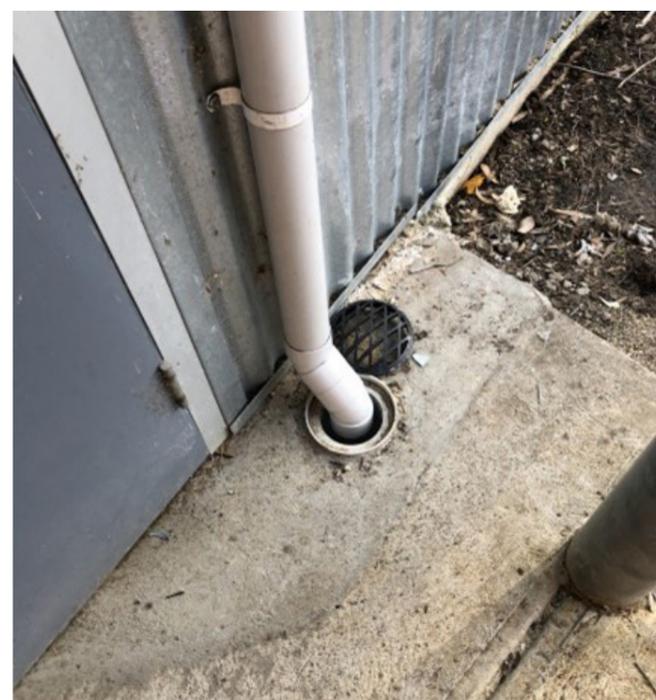
- The downpipe was discharging into the sewerage system (via the overflow relief gully); a non-compliant method of terminating a stormwater installation that had the potential to cause significant damage and health risks to the dwelling and occupants.
- A box gutter sump was not sized to the standard of 400 mm in length and 150mm in depth and the downpipe connected to it was also undersized to the standard of min 90mm or 100mm x 50mm.
- The overflow provision required to be installed into the sump did not meet the standard of discharging any water clear of the dwelling.
- Insufficient support provided at the base of a box gutter as per AS/NZS 3500.3 2015 cl 5.3.4.

Non-compliant downpipe discharge AS/NZS 3500.3 2018 cl 3.7.8 (b) NCC 2019 Volume Three Section C & Vic Section F

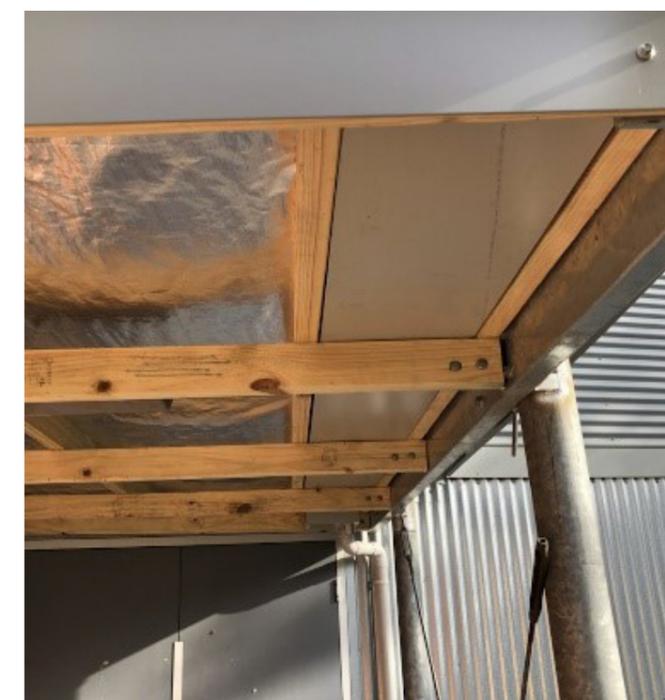
Insufficient support for box gutter as per AS/NZS 3500.3 2015 cl 5.3.4
