Technical Solution Sheet 0.02

0: Roof Plumbing

V-Gutters

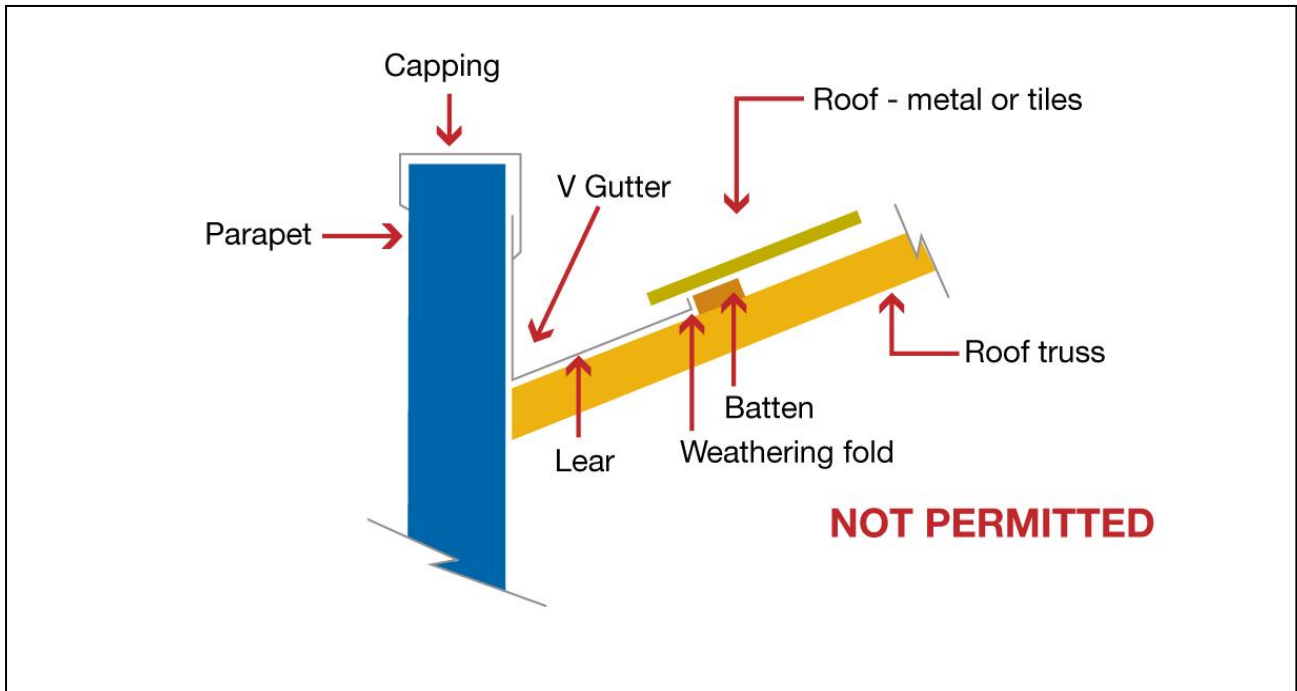
FIGURE 1 – TYPICAL INCORRECT V-GUTTER

Most of the instances of sub-standard “V” gutters have occurred because a roofing practitioner followed a building design, and failed in their own obligation as a professional to check that the design can be certified. The “V” gutters commonly abut a parapet wall and are installed directly onto the roof battens or trusses. As a result the gutters are laid without any fall and while the ends of the gutter may be open to a rainhead or other roof, there is incomplete drainage, and the gutter soon becomes clogged with debris (see Figure 1).

- Inadequate drainage with water / or debris accumulating in the gutter causing overtopping of the gutter.
- Corrosion and premature failure of the gutter due to inadequate drainage and intense localised corrosion caused by permanent ponding and debris accumulating in the crevices.
- The “V” fold, being well in excess of 90° can cause damage the protective coating of the gutter material causing premature failure.
