PROACTIVE INSPECTIONS PROGRAM

Activity Report

FINANCIAL YEAR 2022-23 Q3

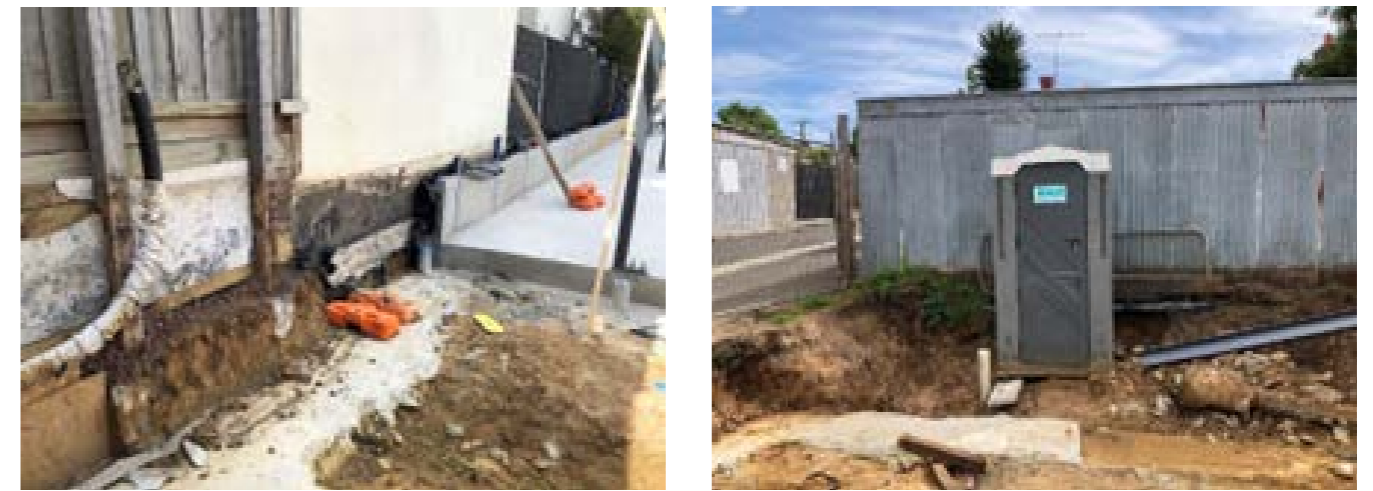
Site cuts on the boundary of the property undermining adjoining properties.

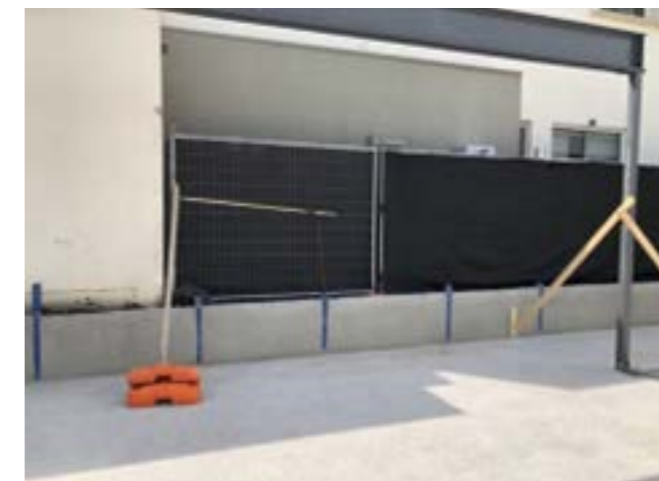
Concrete slab had not been constructed in accordance with approved engineer's design which included square hollow sections installed within the slab.

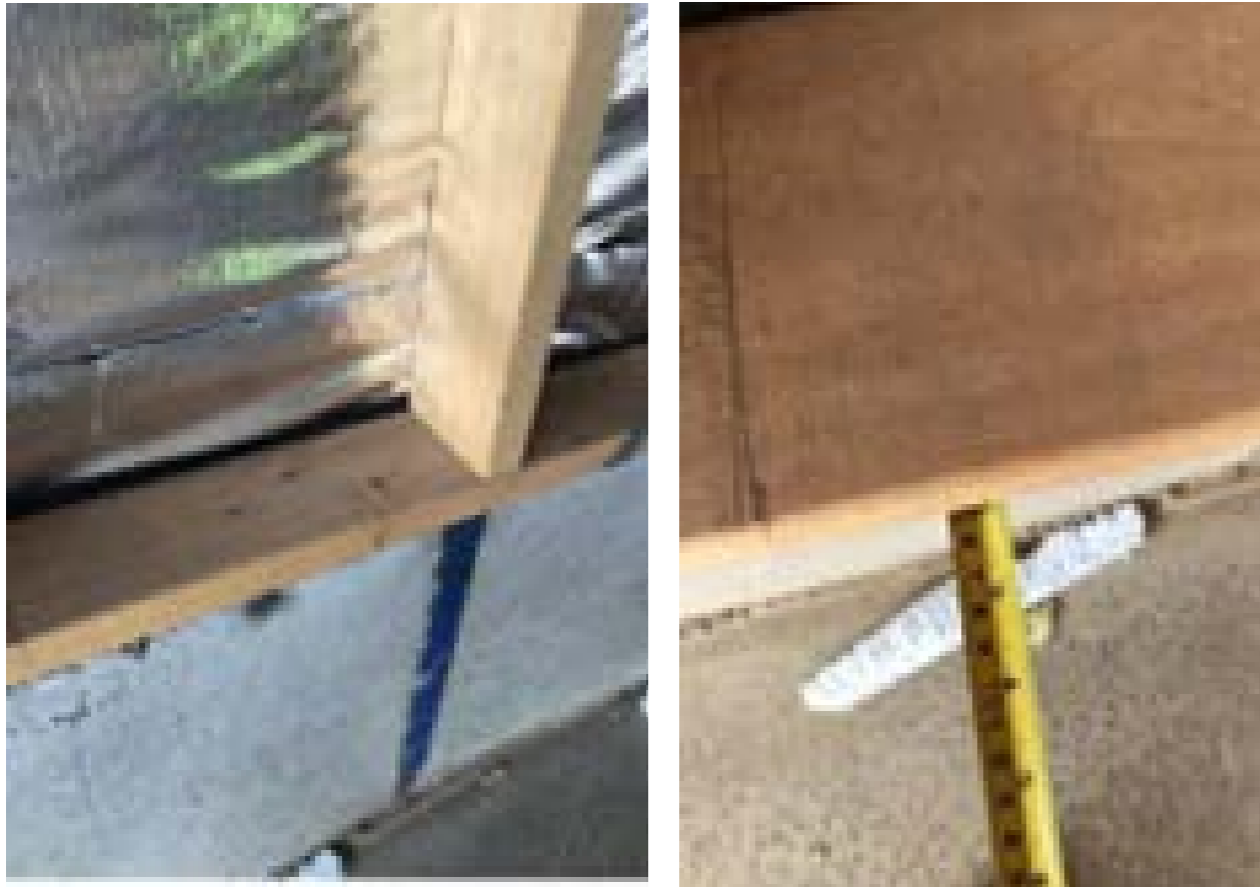
Timber bottom plates overhanging slab by 50mm.

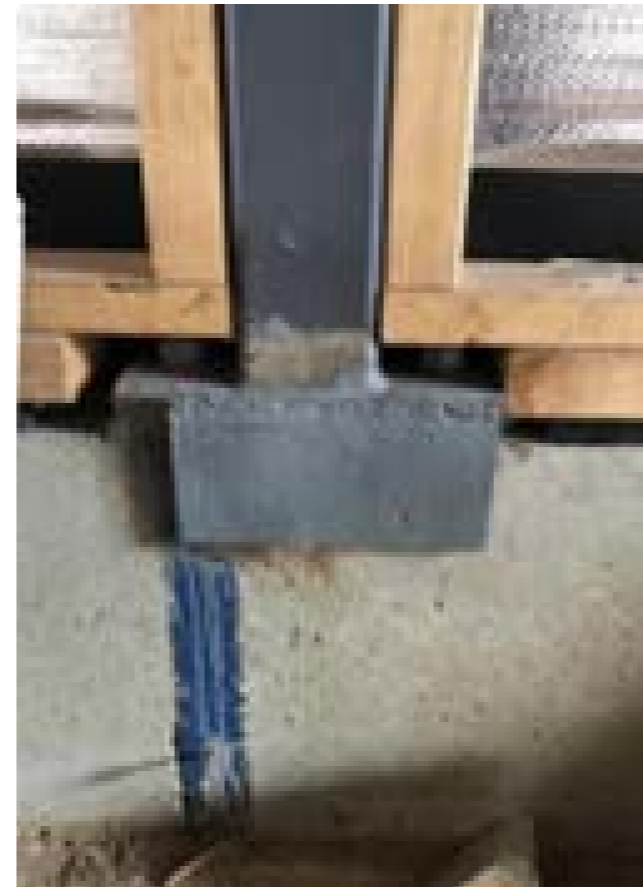
P2 posts were not installed as per the engineering documents and bolted connection from above fell within square hollow section.

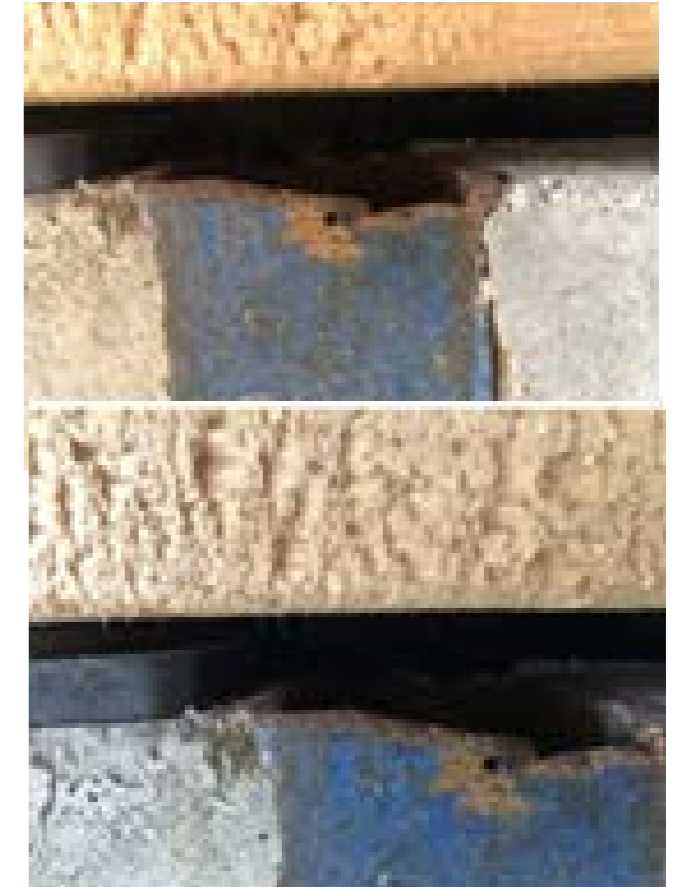
Bottom plates installed on large amounts of packers with inadequate fixings.

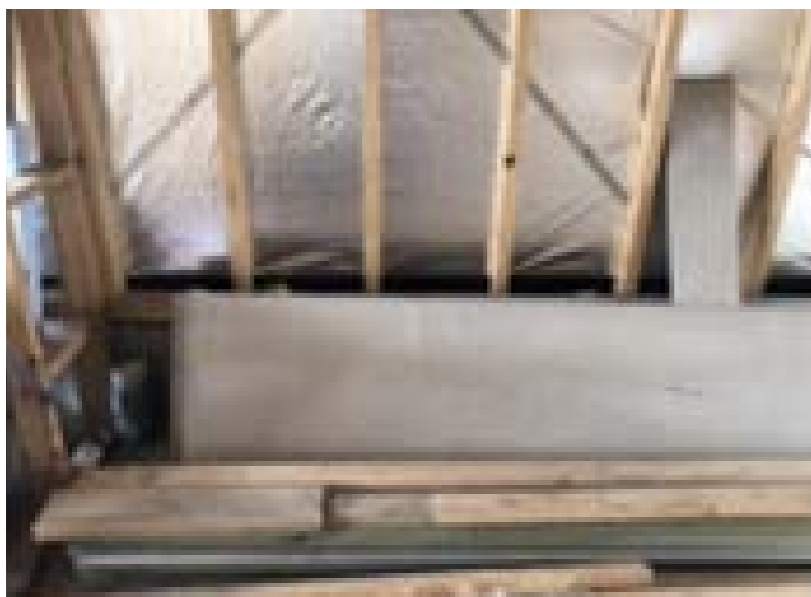
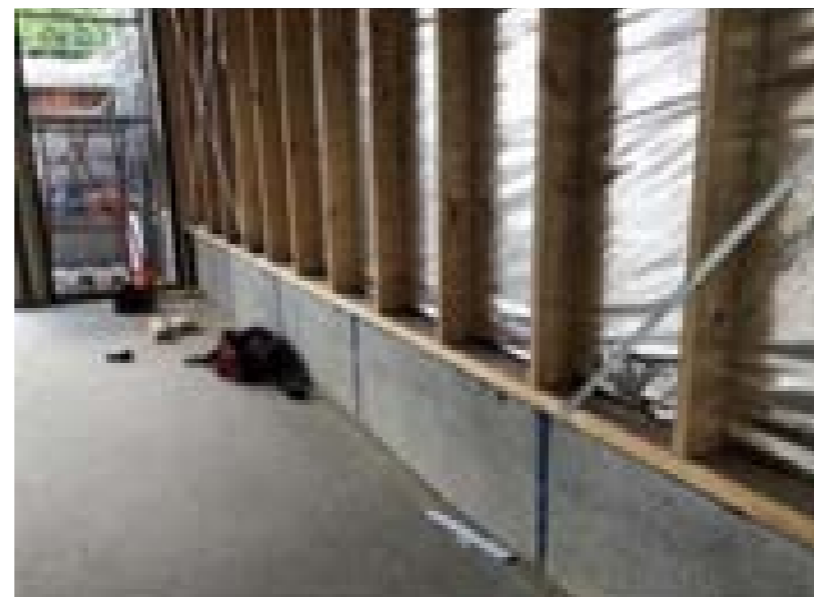
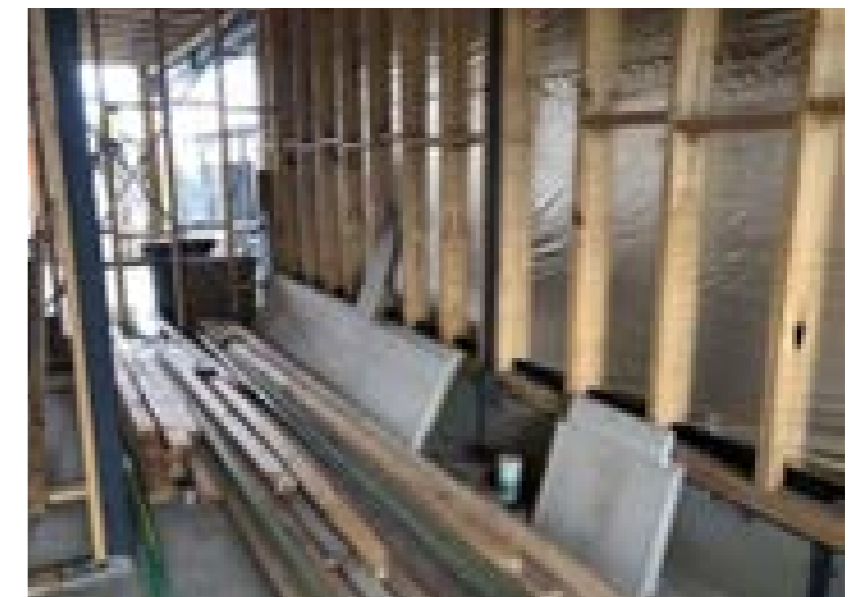
Wall braces not installed in accordance with the engineering documentation and missing

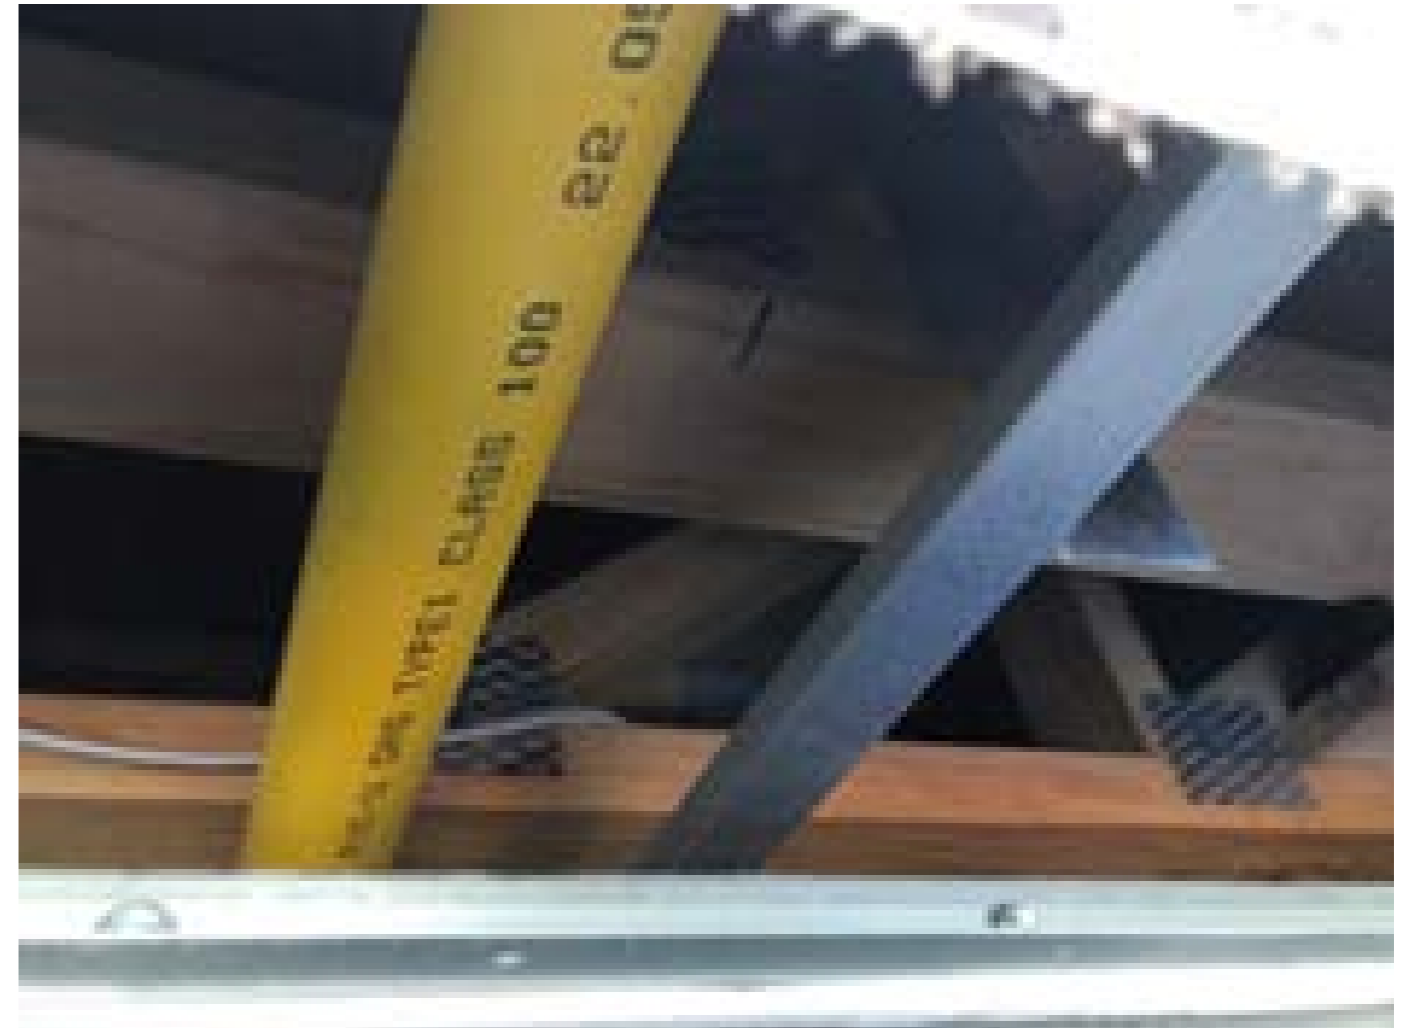
Non-compliant plastic gas pipework material used below a building.

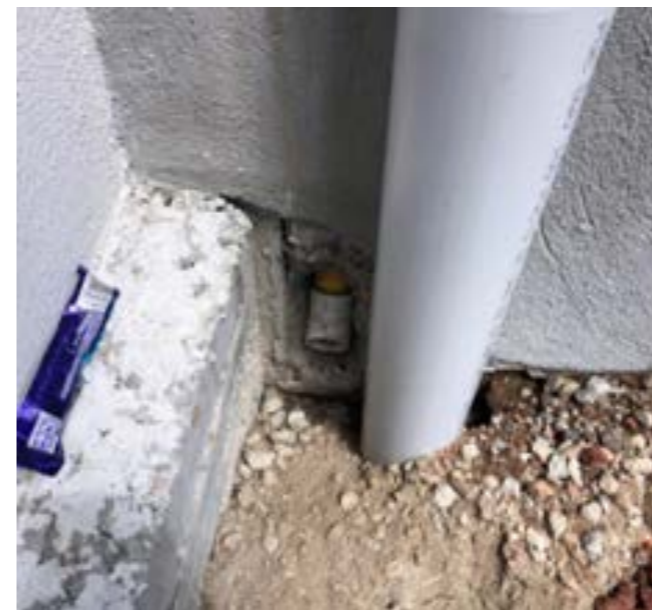
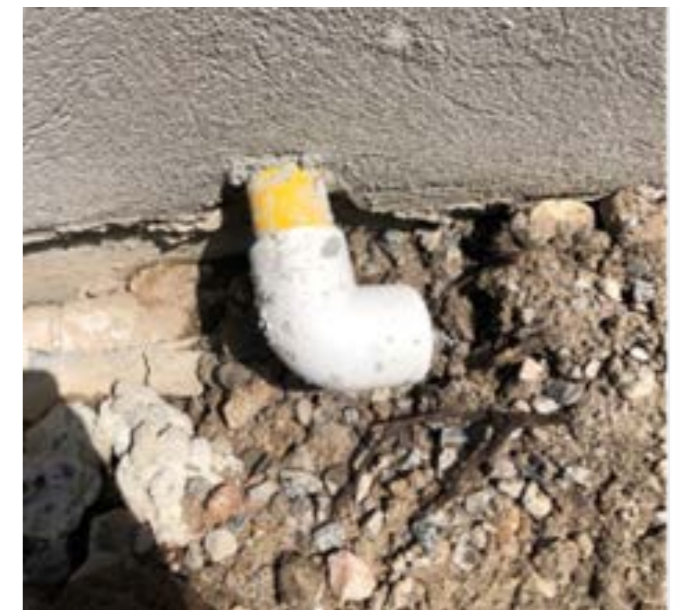
Non-compliant plastic gas pipework material used above ground.
