PROACTIVE INSPECTIONS PROGRAM

Activity Report

FINANCIAL YEAR 2022-23 Q4

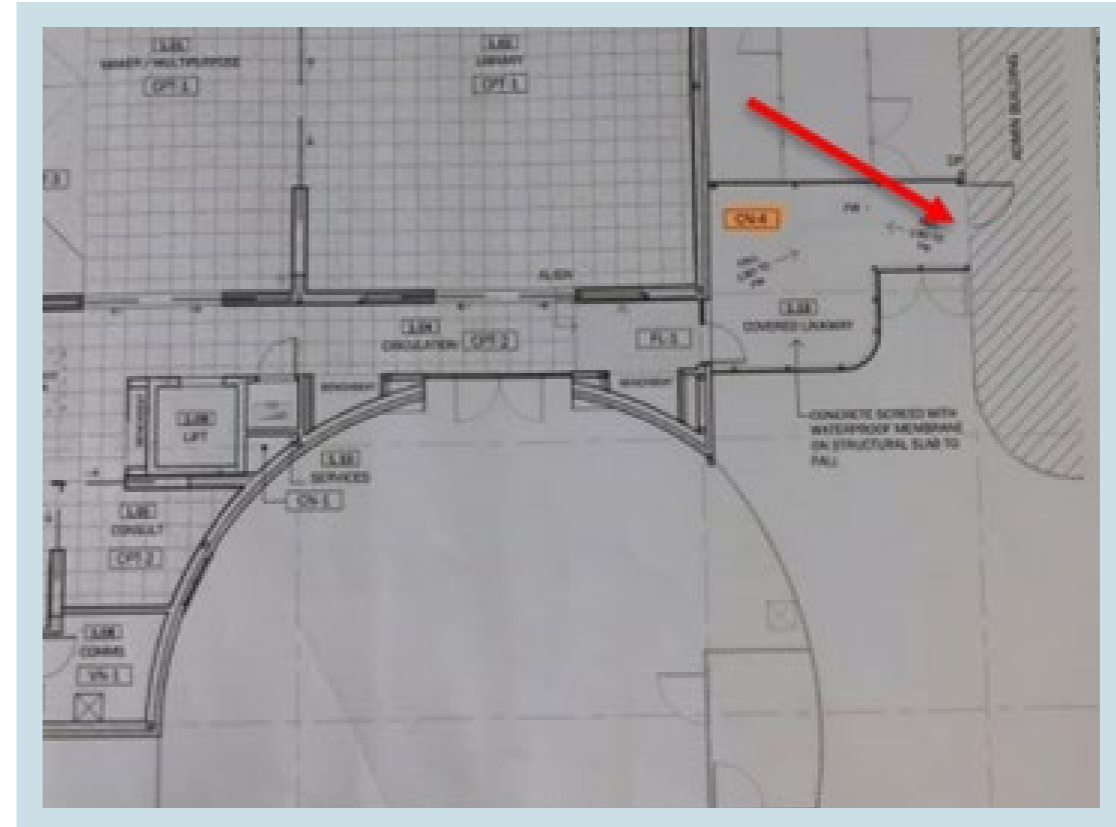
Example of door opening out to a linkway that did not have an upturn of 50mm or a grate.

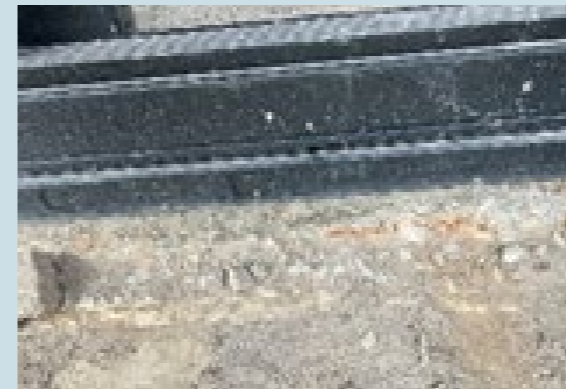
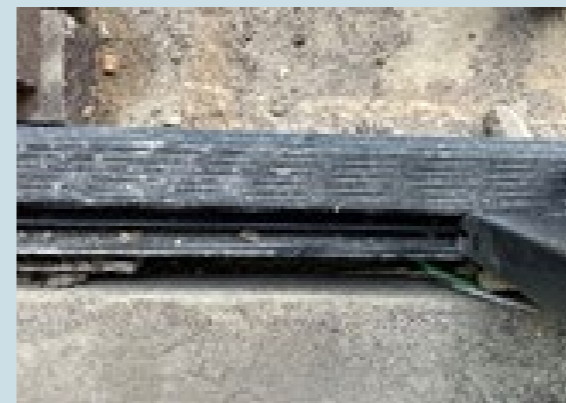
BEFORE

A proactive inspection of a three-storey apartment building, (with lower ground carpark), identified the balconies' waterproofing membranes did not continue under the windowsills and there were no subsill flashings, contrary to FP1.4 of Volume 1 of the BCA/Clause 2.8.3 of AS 4654.2.

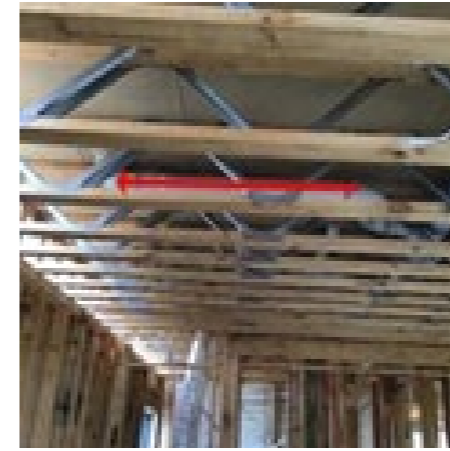
Discharge pipes do not have the appropriate grade contrary to AS/NZS 3500.2:2021 Table 6.6.1

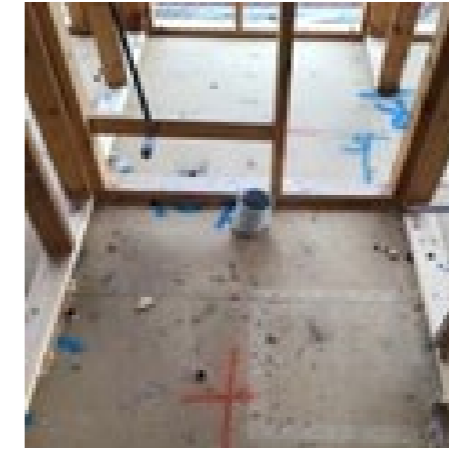
Some risers are not installed parallel, pipe work shall be in the same alignment and grade as the preceding pipes or fittings. AS/NZS 2032:2006 Clause 4.2.3

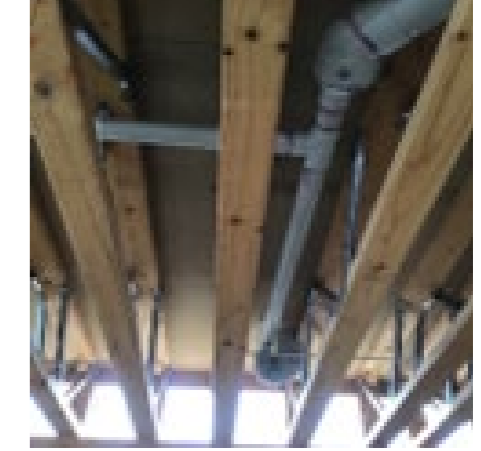
The non-compliances related to a range of poor sanitary drainage work that could have resulted in recurring blockages and water ingress. This work included an incorrectly designed stack (leading to incorrect venting) that did not achieve a minimum grade and PVC joints not constructed appropriately. This could lead to recurring leakages and blockages in the sanitary drainage system and, fixtures (e.g., showers/toilets) not operating efficiently. Stacks are commonly costly to repair as it requires the removal of waterproofing, tiles, and plaster to conduct repairs and the dwelling may become uninhabitable while works are being repaired.

Incorrect junctions and venting of the sanitary drains contract to AS/NZS 3500.2:2021 clause 9.5.2 & 9.2.2 AS/NZS 3500.2:2021 Clause 6.6.2.3

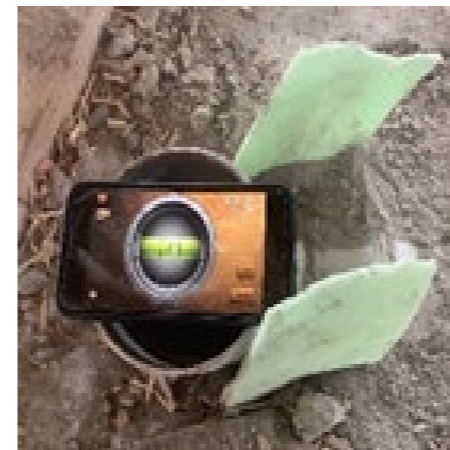
Gradient of drain going backwards contrary to AS 3500.2:2021.clause 3.4.1

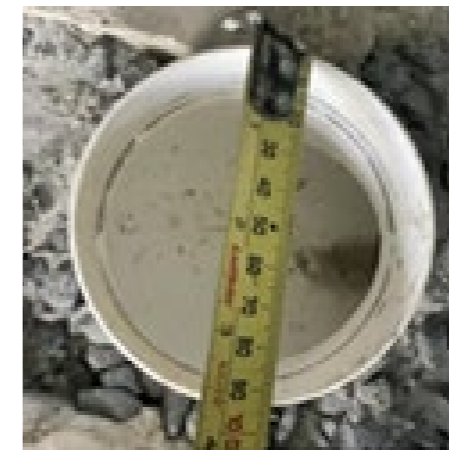
Additionally, 90mm stormwater PVC was installed and used on a below ground sewer drainage system and PVC joints were not constructed correctly. This could have resulted in water leaking into and under the building's structure.

90mm PVC piping. not suitable for sanitary drainage systems contrary to AS/NZS 3500.2:2018 clause 2.3 and manufactures installation specifications.

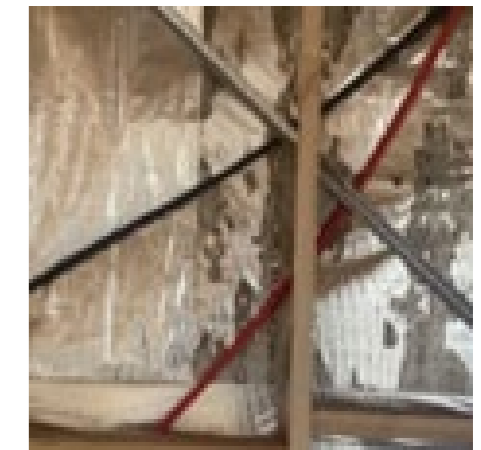
Water pipes exceed the maximum clip spacings contrary to AS/NZS 3500.1:2021 Table 5.7.4 AS/NZS 3500.4:2021 Table 4.5.4
