Building Documentation Audit

Volume 2 - Class 1a

July 2022 – February 2023

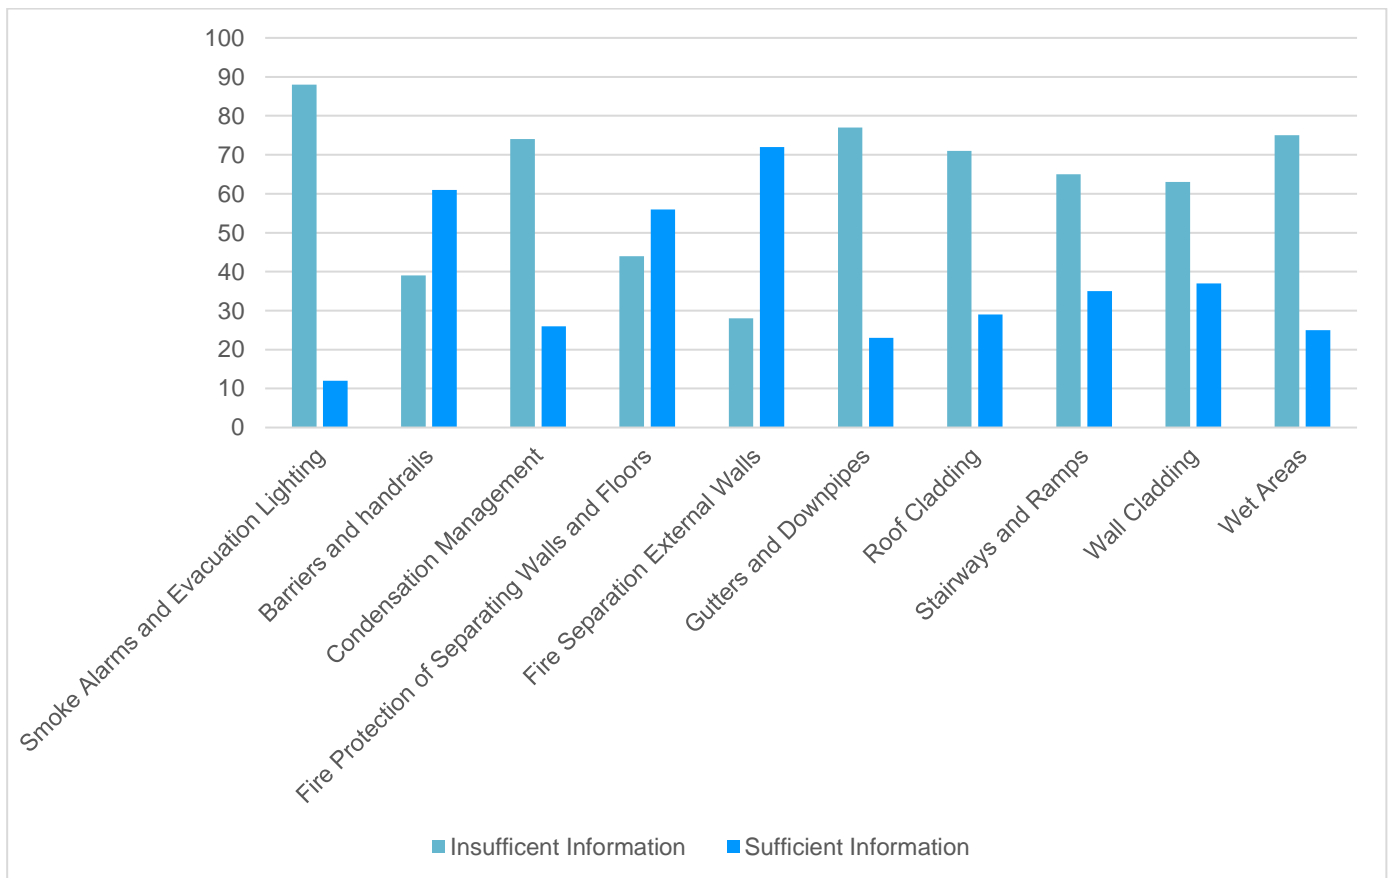
Figure 3. Documentation insufficiencies across all audits, where applicable. Figure 3 is a graph that shows a comparison of sufficient information and insufficient information for each category type.

Documentation insufficiencies across all audits are shown in Figure 3.

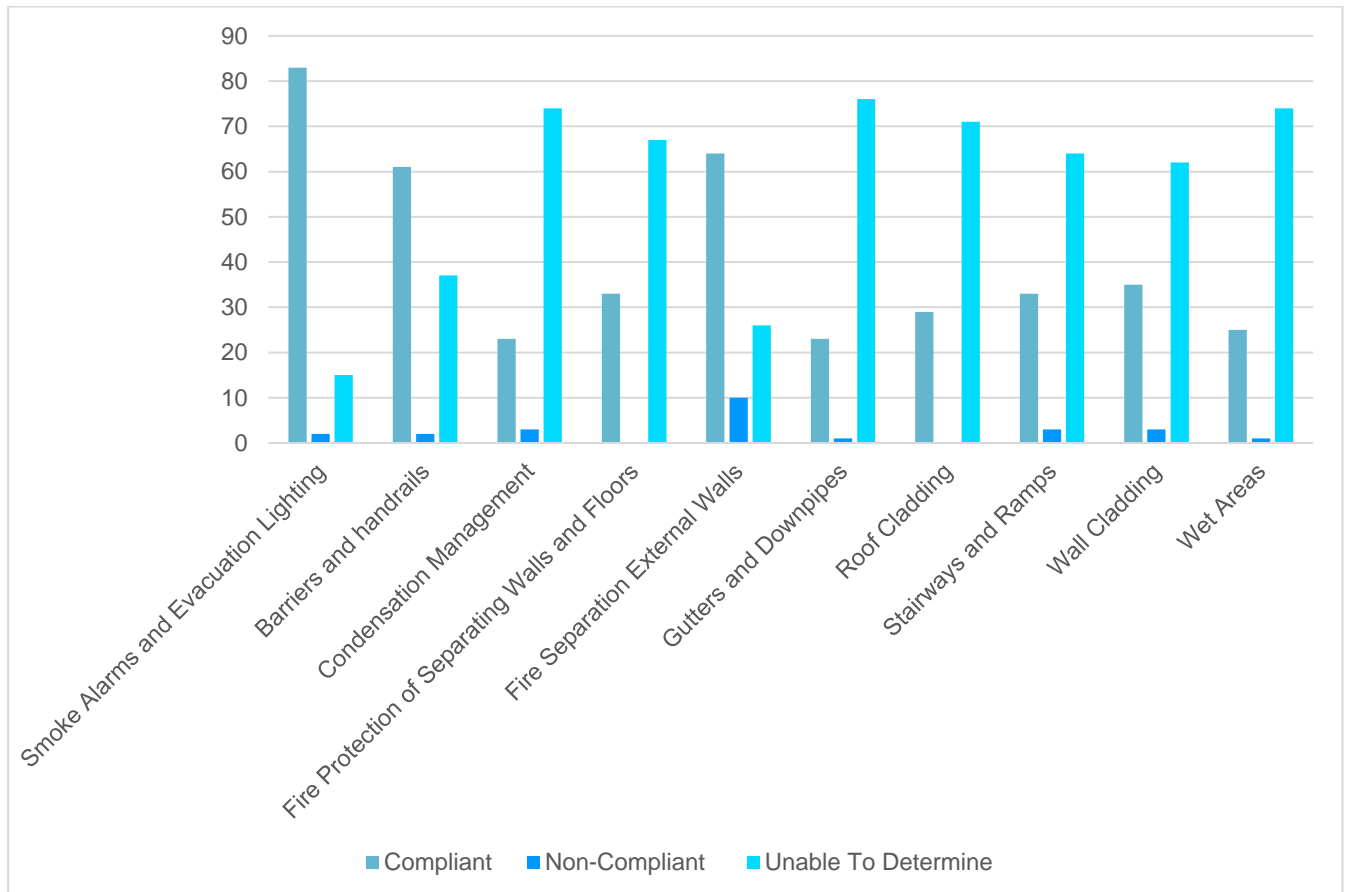
Figure 4. Compliance level across all audits. Figure 4 shows a comparison between the compliance levels of compliant, non-compliant and unable to determine for each category type.

The compliance levels, that is where compliance had been demonstrated, across all audits are shown in Figure 4.
