Proactive Inspections Program

Activity report

July – September 2020

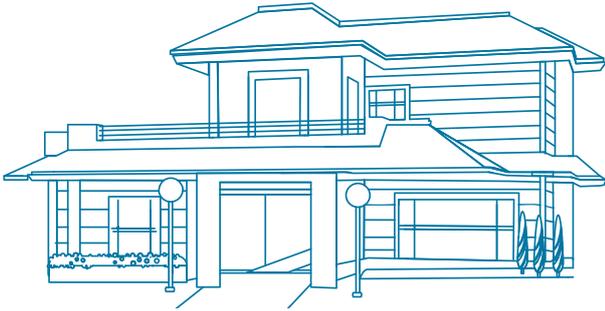
Single occupancy

Prevalence of compliance risks

Building 26%
