Building Documentation Audit Volume 2 - Class 1a

March 2023 - August 2023

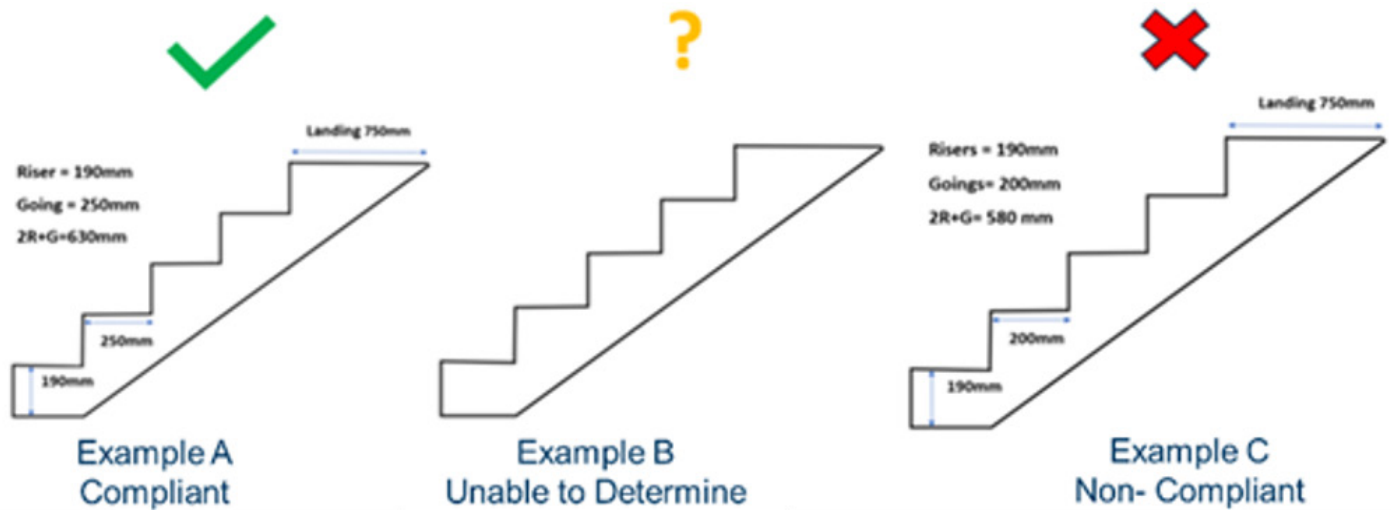
Figure 2. Compliance levels. Figure 2 shows three different stairs with their associated compliance levels.

There are three compliance levels which are linked to sufficiency of information. These are illustrated in Figure 2. Compliances levels.

An item is deemed compliant where there is sufficient information to be satisfied that the clause has been complied with, either through DtS or a performance solution, as shown in example A of Figure 2, where there is sufficient information to determine the stair going and riser are DtS compliant.

Where there is insufficient information, for example where there are no details of the goings or risers, such as example B of Figure 2, we would assess this as being unable to determine.

Lastly, an item is marked as non-compliant when there is a physical non-compliance detailed. As shown in Example C where the going is not the minimum required.
