# Proactive Inspections Program (PIP) Activity

April – June 2020

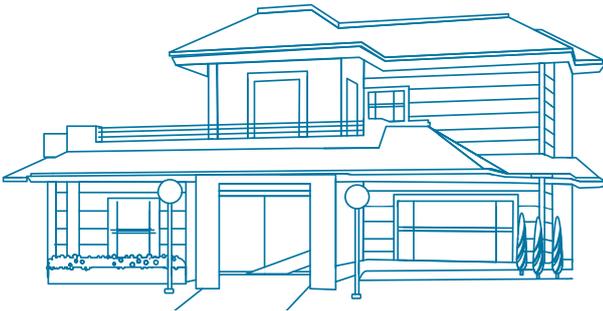
### Single occupancy

Prevalence of compliance risks

**Building 27%**

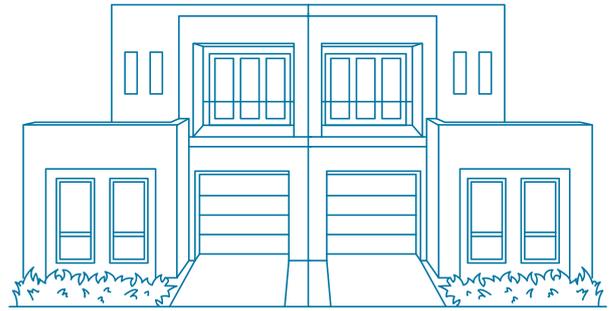
### Dual occupancy

#### Common building issues

Timber framing  
Fire separation  
Unreinforced masonry  
Openings in platforms/stair voids  
Working >2.0 m in height
