Building Surveyor Audit Program

Volume 1 Class 2 – 9 Buildings

January 2022 – June 2022

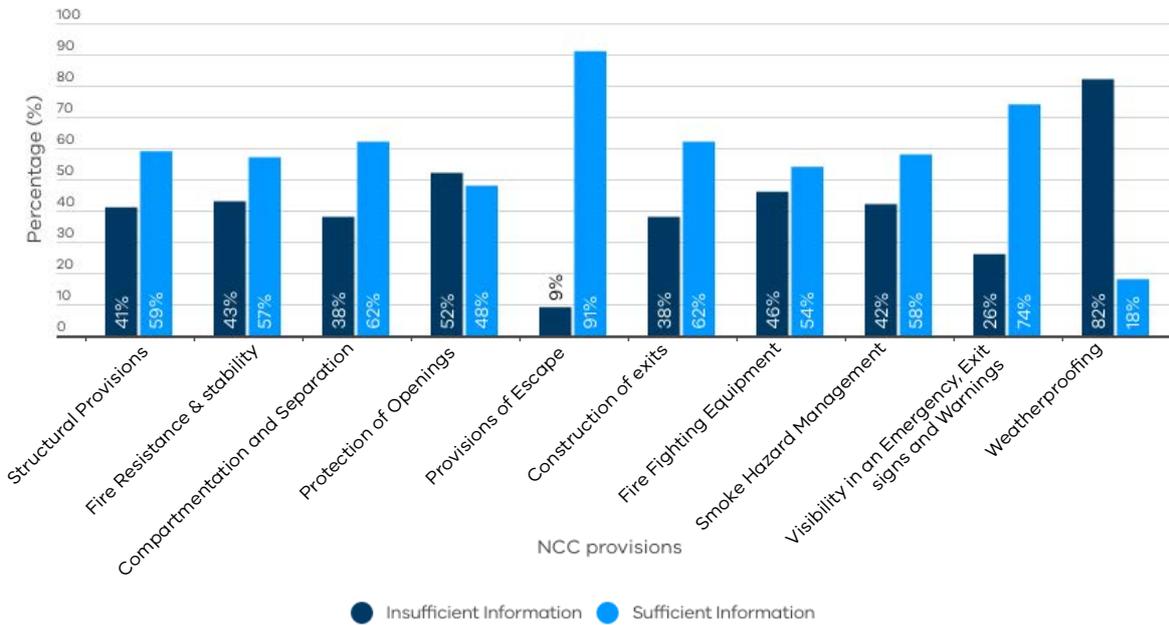
Figure 2. Documentation insufficiencies across all audits, where applicable.

Documentation insufficiencies across all audits are shown in Figure 2.

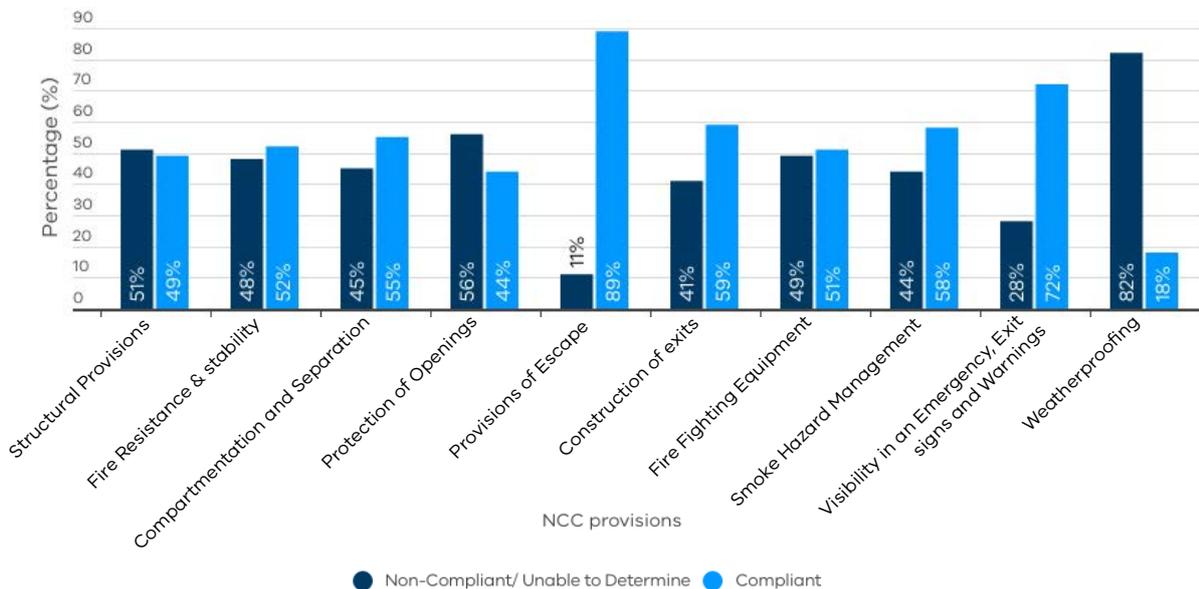
Figure 3. Compliance level across all audits.

The compliance levels, that is where compliance had been demonstrated, across all audits are shown in Figure 3.

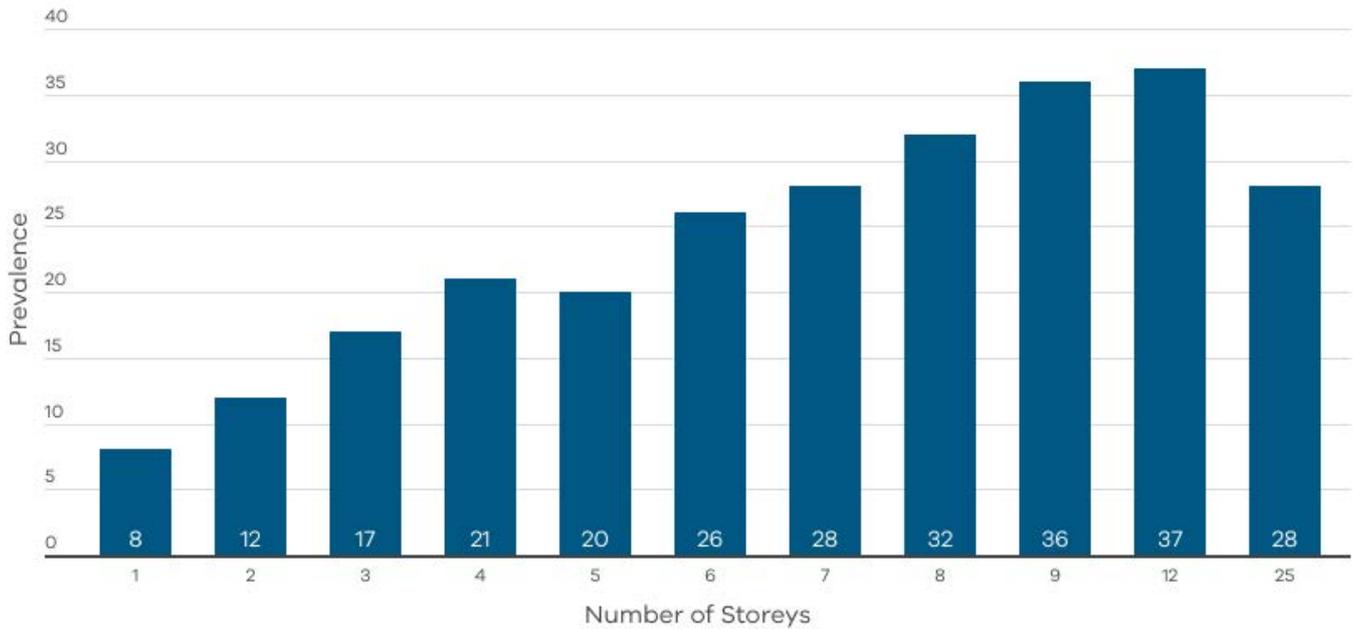
Figure 4. Compliance issues across all audits per number of storeys¹.

The average prevalence of compliance not being demonstrated based on the rise in storeys¹ across all audits are shown in Figure 4.

¹Limited number of audits undertaken on 5, 6, 8 and 12 storey buildings. No audits on those rise in storeys not listed.

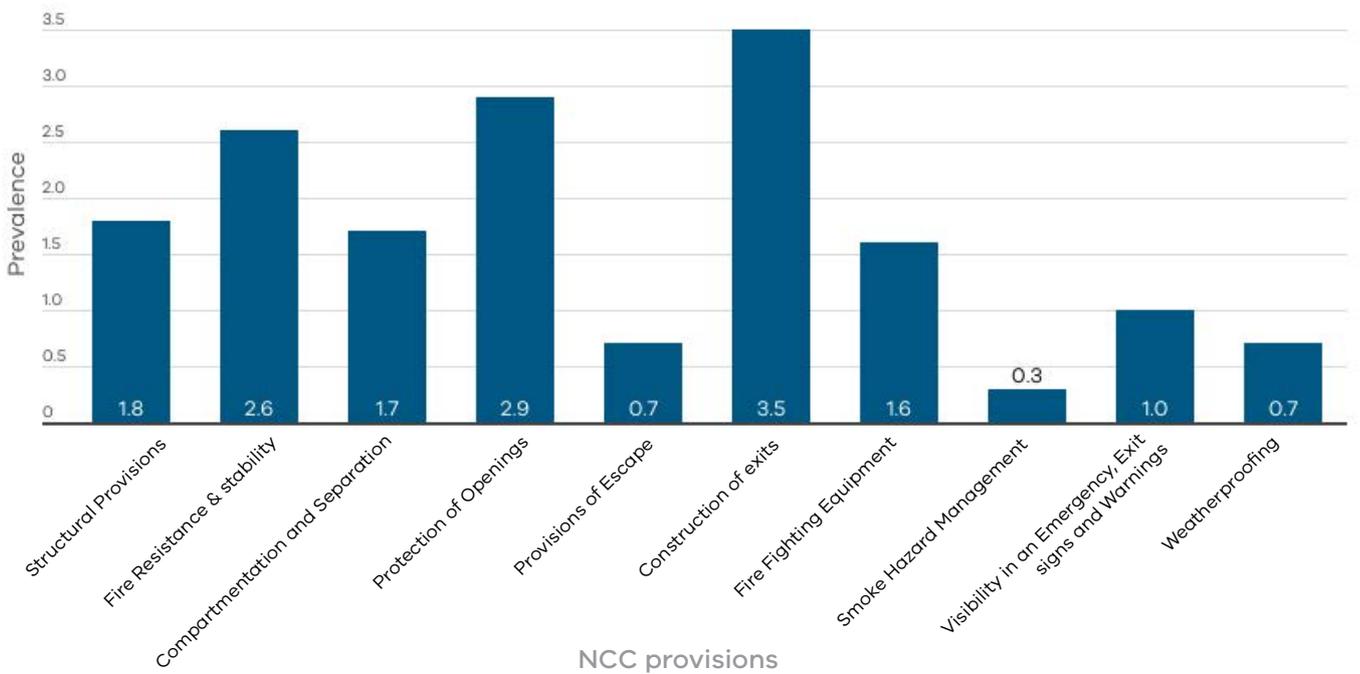
Figure 5. Average compliance not being by NCC provisions across all audits.

The average prevalence of items where compliance was not being demonstrated based on NCC provisions across all audits are shown in Figure 5.
