PROACTIVE INSPECTIONS PROGRAM

Activity Report

FINANCIAL YEAR 2022-23 Q2

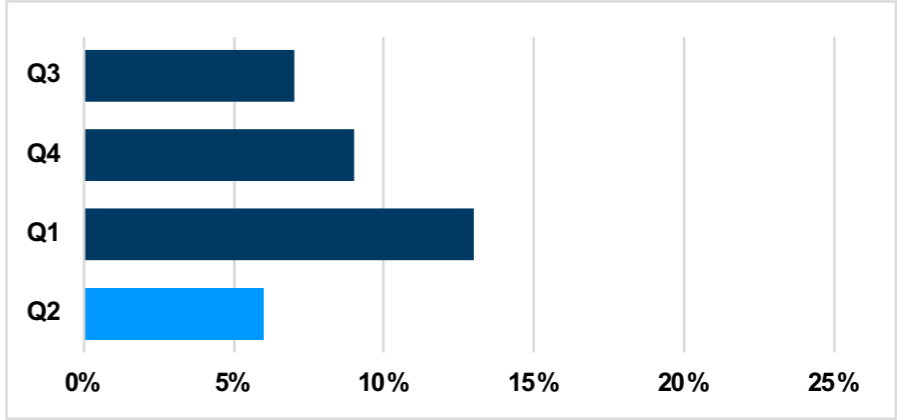
Plumbing category	No. of non-compliant items in category	Common non-compliance in each category	Prevalence per quarter										
Cold water	5	<ul style="list-style-type: none"> • Backflow prevention required on flexible shower hoses that reach the floor and toilet. • Insufficient separation from electrical and gas services and recycled water, fire and water services clipped together. • No pressure limiting devices installed into meter assembly. • Water service not protected through slab.

<table border="1"> <caption>Prevalence per quarter for Cold water</caption> <thead> <tr> <th>Quarter</th> <th>Prevalence (%)</th> </tr> </thead> <tbody> <tr> <td>Q3</td> <td>7.5%</td> </tr> <tr> <td>Q4</td> <td>9%</td> </tr> <tr> <td>Q1</td> <td>13%</td> </tr> <tr> <td>Q2</td> <td>6.5%</td> </tr> </tbody> </table>	Quarter	Prevalence (%)	Q3	7.5%	Q4	9%	Q1	13%	Q2	6.5%
Quarter	Prevalence (%)												
Q3	7.5%

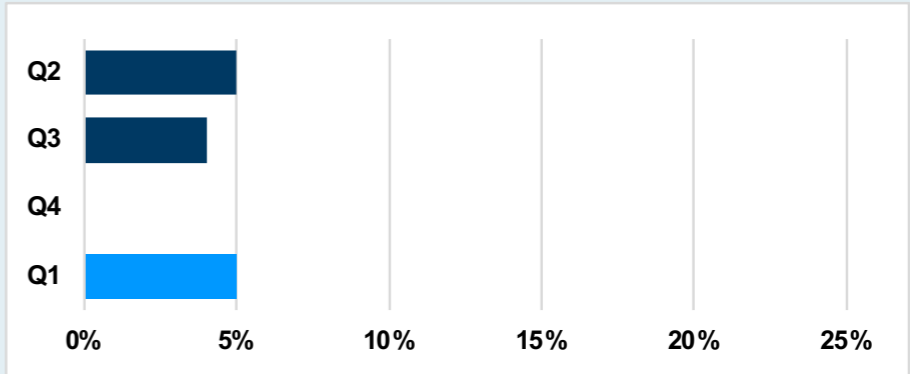
Q4	9%												
Q1	13%												
Q2	6.5%												
Heated water services	3	<ul style="list-style-type: none"> • Insufficient separation from electrical services. • Solar hot water copper pipework not lagged in ceiling space.

<table border="1"> <caption>Prevalence per quarter for Heated water services</caption> <thead> <tr> <th>Quarter</th> <th>Prevalence (%)</th> </tr> </thead> <tbody> <tr> <td>Q2</td> <td>5%</td> </tr> <tr> <td>Q3</td> <td>4%</td> </tr> <tr> <td>Q4</td> <td>0%</td> </tr> <tr> <td>Q1</td> <td>5%</td> </tr> </tbody> </table>	Quarter	Prevalence (%)	Q2	5%	Q3	4%	Q4	0%	Q1	5%
Quarter	Prevalence (%)												
Q2	5%												
Q3	4%												
Q4	0%												
Q1	5%												
Services sanitary drainage systems	4	<ul style="list-style-type: none"> • Minimum required separation between ORG and the lowest fixture not met. • No concrete support under drainage bends and sewer drainage with incorrect fall.

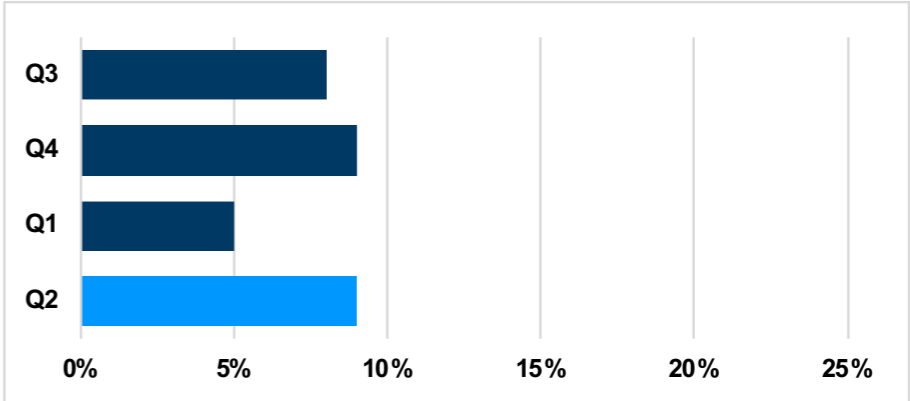
<table border="1"> <caption>Prevalence per quarter for Services sanitary drainage systems</caption> <thead> <tr> <th>Quarter</th> <th>Prevalence (%)</th> </tr> </thead> <tbody> <tr> <td>Q3</td> <td>8%</td> </tr> <tr> <td>Q4</td> <td>9%</td> </tr> <tr> <td>Q1</td> <td>5%</td> </tr> <tr> <td>Q2</td> <td>9%</td> </tr> </tbody> </table>	Quarter	Prevalence (%)	Q3	8%	Q4	9%	Q1	5%	Q2	9%

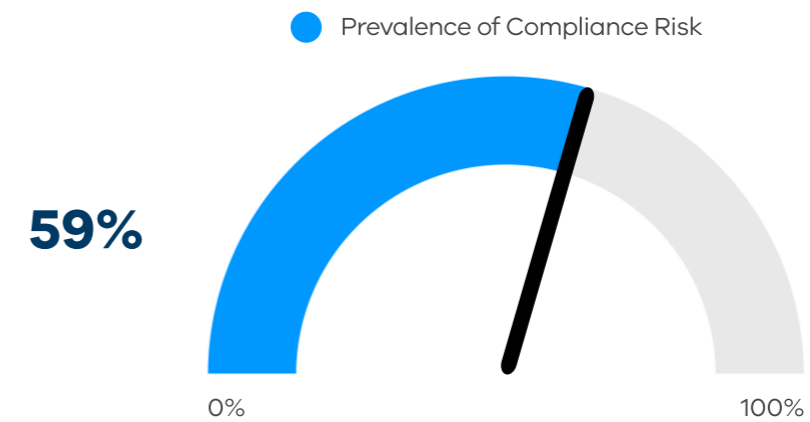
Figure 3.1: This graph shows the prevalence of compliance risks observed in plumbing inspections of dual occupancy dwellings.
